MEMORANDUM

Subject: Monthly Report from March 10th to Date.

ROUTE 107 WATER FILTRATION PLANT

FILTER INSPECTION REPORT

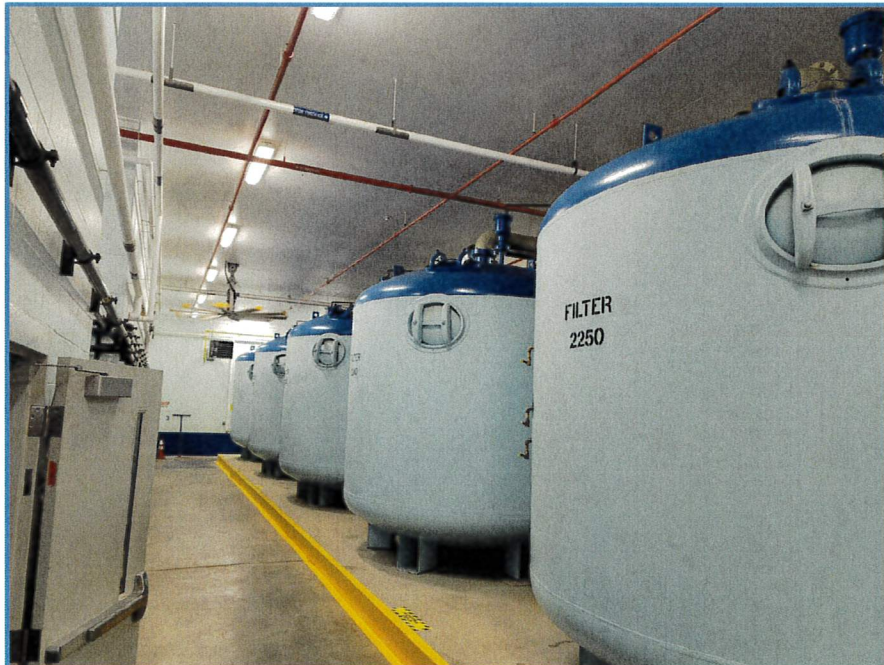
VERTICAL PRESSURE FILTER REPORT CARD

Measurements / Conditions				
Filter Number	#3	#5		
Depth of Anthracite	16"	18"		
Thickness of Interface	2"	1"		
Depth of Greensand	5"*	12"*		
Total Media Depth	23"	31"		
Freeboard	42"	42"		
Draindown port to media	9"	9"		
Mounding (Y/N)	No	No		
Cracking (Y/N)	No	No		
Solids Present (Y/N)	Y	Y

1. Support gravel found to be extremely displaced in both filters.
2. Some Greensand Plus loss has occurred. Likely a result of the compromised gravel layers. GSP has likely migrated into the underdrains.
3. Empty filters routinely refilled with filter influent. Not best practice, entrapped air in filter media can cause gravel displacement.

The gravel migration present is likely being caused by the plant’s operating procedure of refilling empty filters using the filter influent (filling empty tanks from the top). This practice will often cause air to become entrained in the filter media and will can cause significant gravel migration. WSP has already worked with the plant to develop a new procedure where empty filters are refilled slowly, from the bottom, using backwash/finished water.

The gravel migration in Filters 3 and 5 is substantial enough to suggest that filter rehabilitation / re-bedding is recommended. Consideration should be given to rebuilding these five (5) filters before gravel/media migration begins to impact filter and underdrain performance.

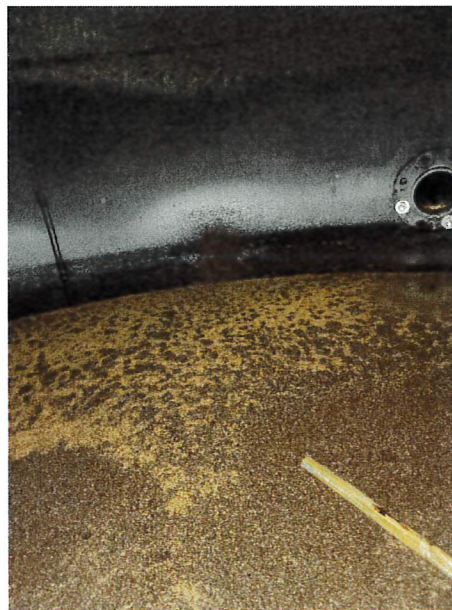
The filter media surface in both filters was in excellent condition. No significant mounds or other surface irregularities to report. Some minor iron accumulation is present of the media surface.

Figure 2 - Example of media surface in filter 3 (2230). Flat and generally free of debris

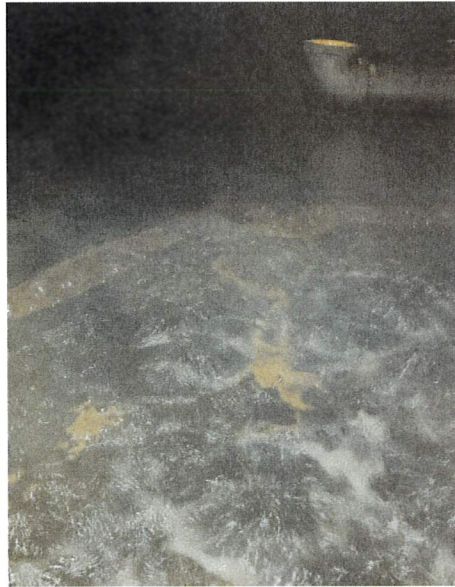
Following each inspection, the filters were refilled by opening the effluent valve. Once the water level was above the filter media surface, the effluent valve was again closed and the air scour system in each vessel was tested. Air scour distribution was excellent in each of the filters tested.

Figure 2: Air Scour pattern from filter #3 (2230)

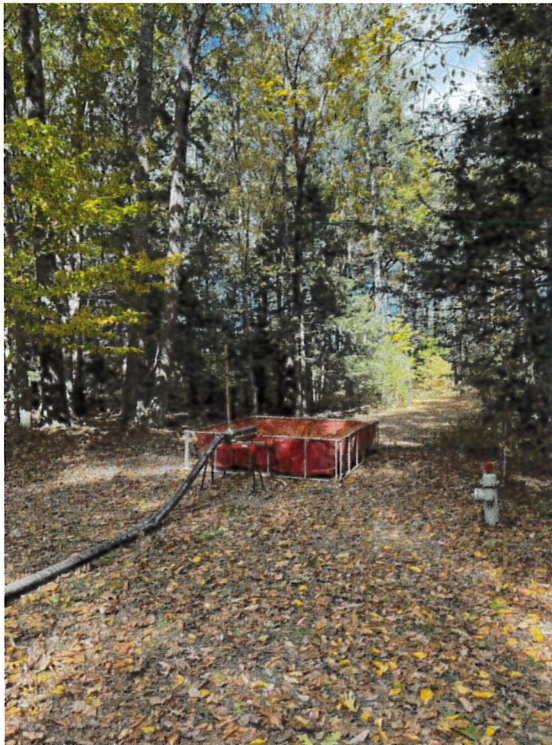
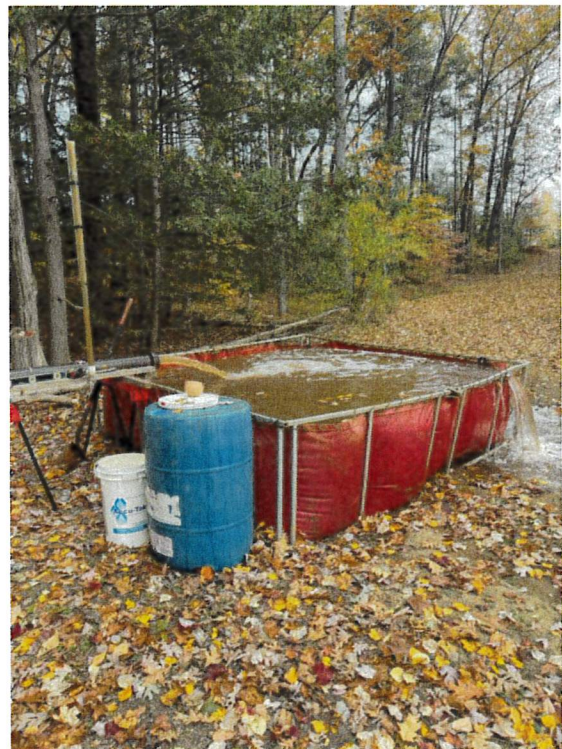
Discharge Catch Basin

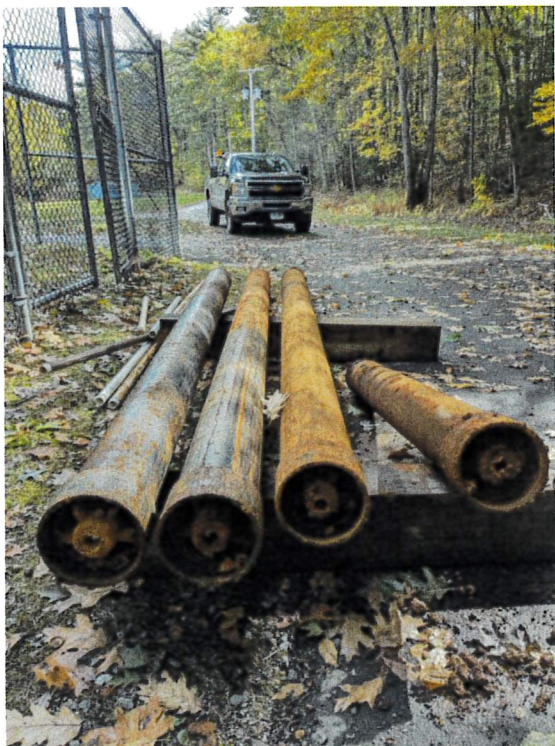
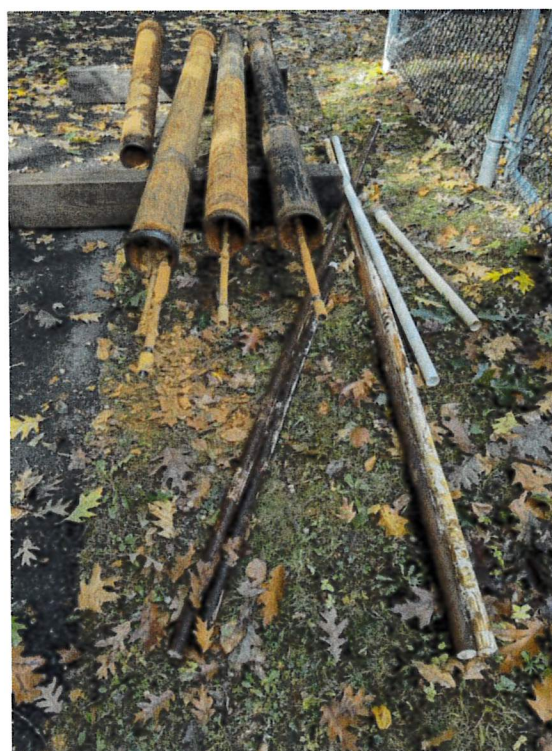
Pre-Redevelopment Column Pipe with Iron Buildup

On February 13, 2025, as requested by SEABROOK, Barrie Miller arrived with 38.6 feet of new 6-inch column assembly to replace the column pipe. A new pump (Model: FW10IC) was installed, along with a new motor shaft to replace the rusted out pieces. Additionally, the motor was reconditioned to improve performance.

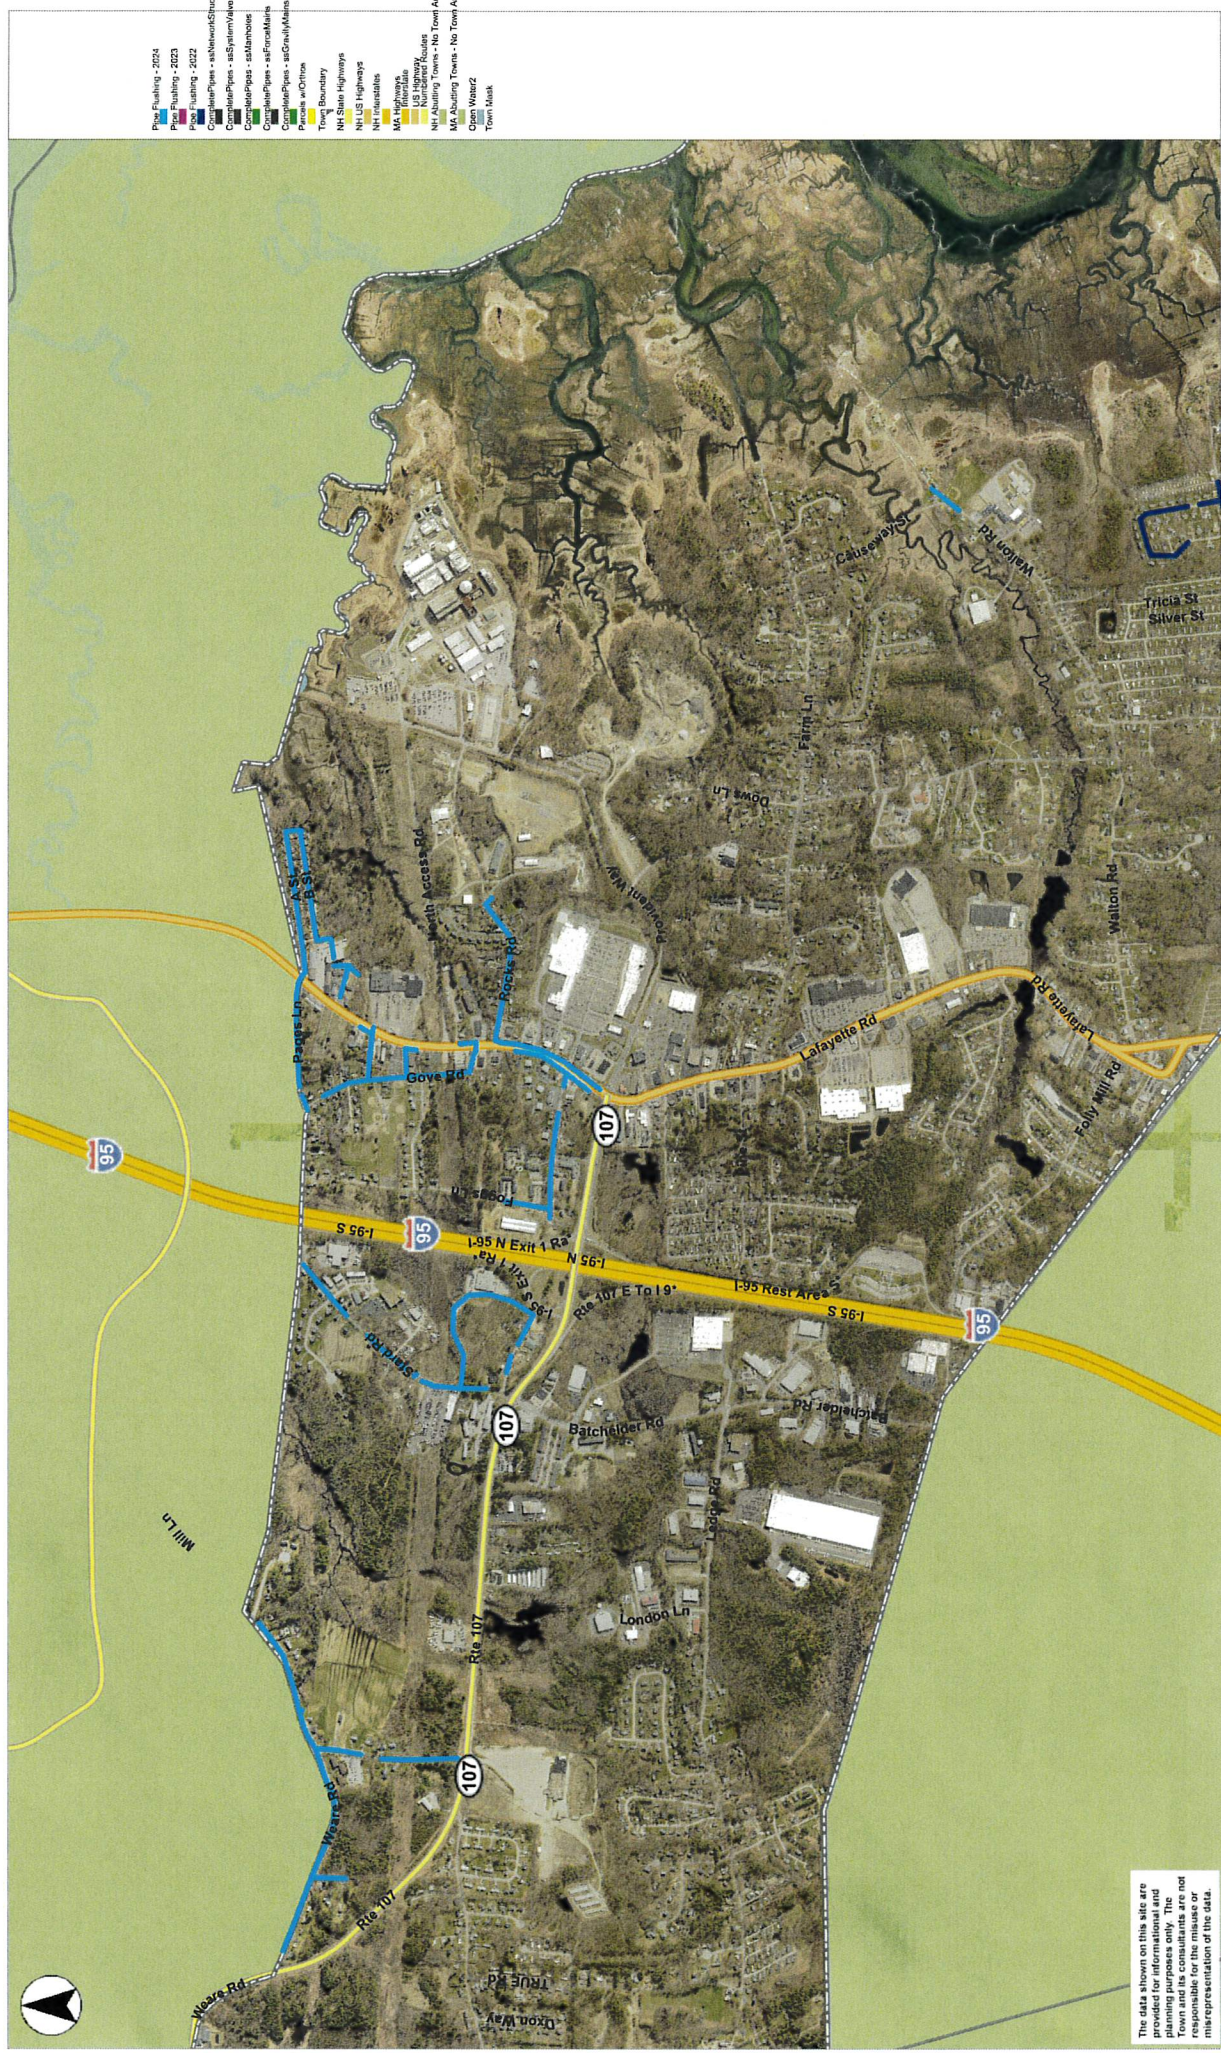
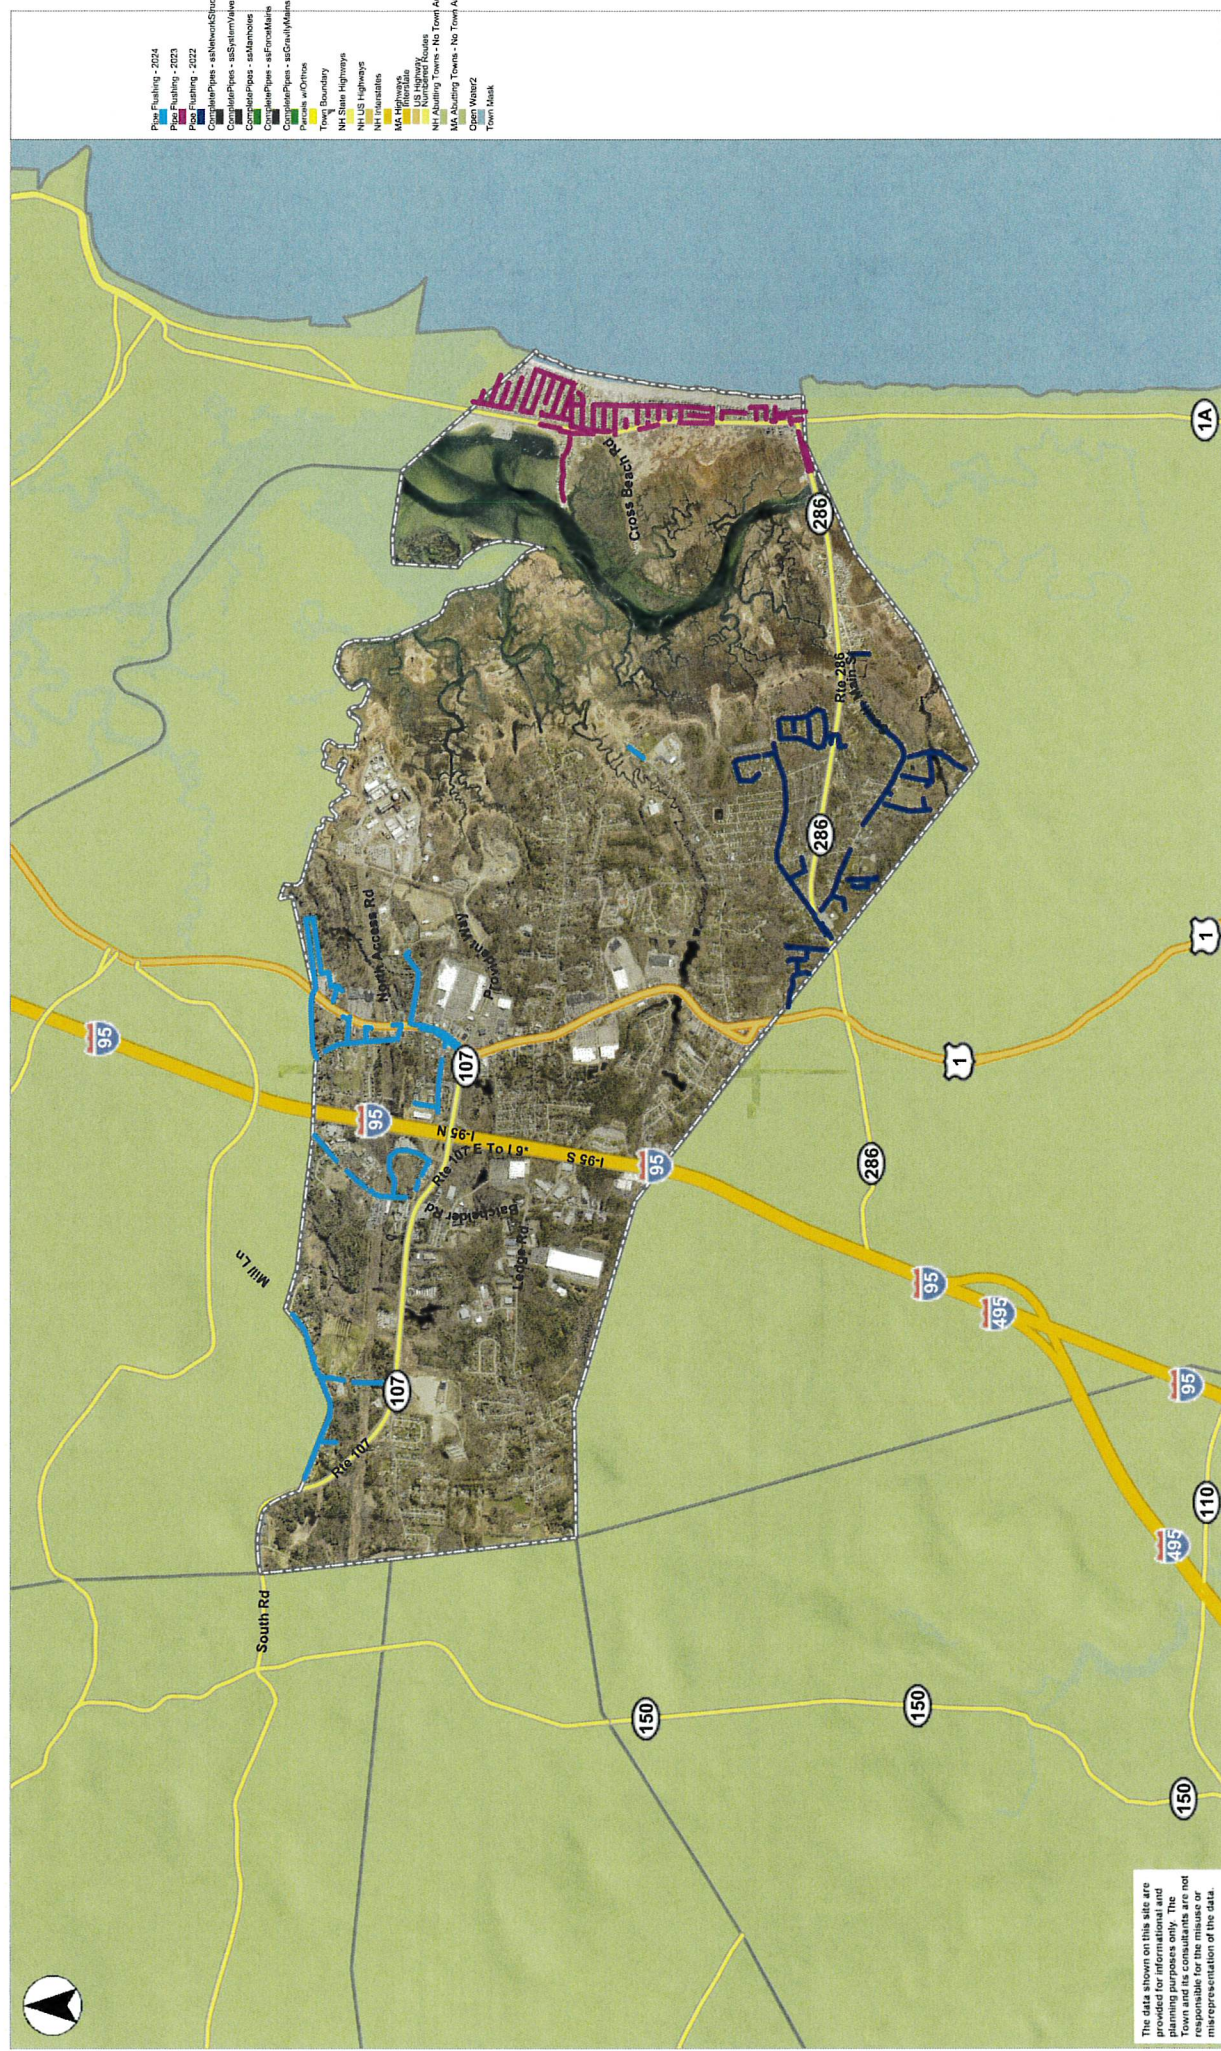
Attachment II
Collection System
Maintenance Map

SS Collection System - Seabrook NH
