WESTON & SAMPSON ENGINEERS, INC.
100 International Dr, Suite 152
Portsmouth, NH 03801
tel: 603.431.3937

FINAL REPORT

TOWN OF
Seabrook
New Hampshire

Weston & Sampson is pleased to submit this report on evaluations conducted on the Town of Seabrook wastewater pump stations. The draft report presents our findings for work completed under this project, including collected pump station information, general observations and deficiencies, recommendations for improvements, and a prioritized master plan.

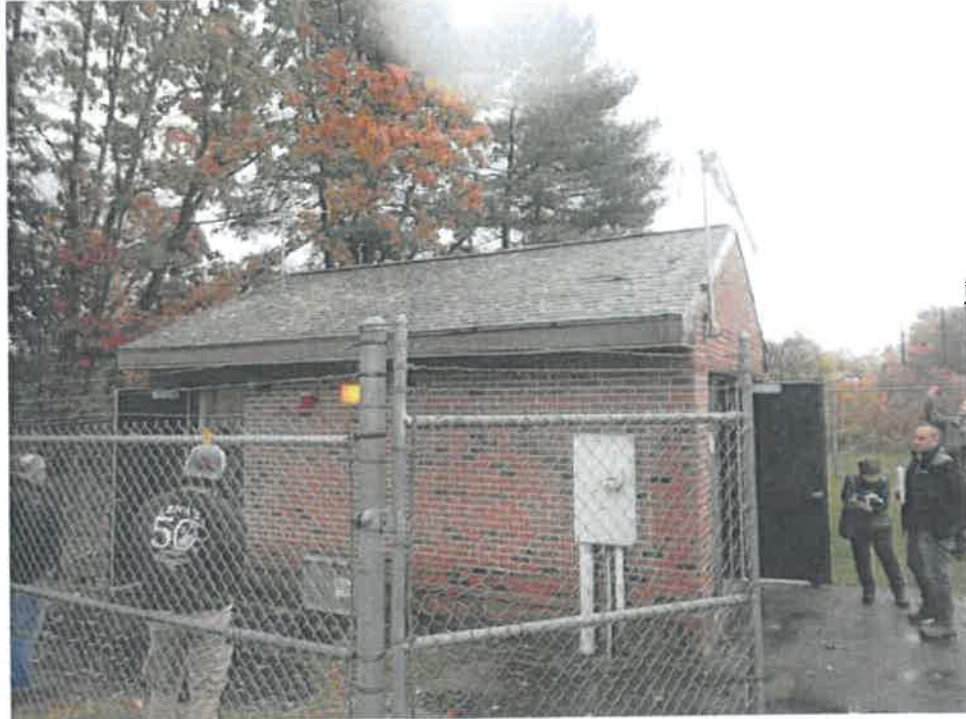
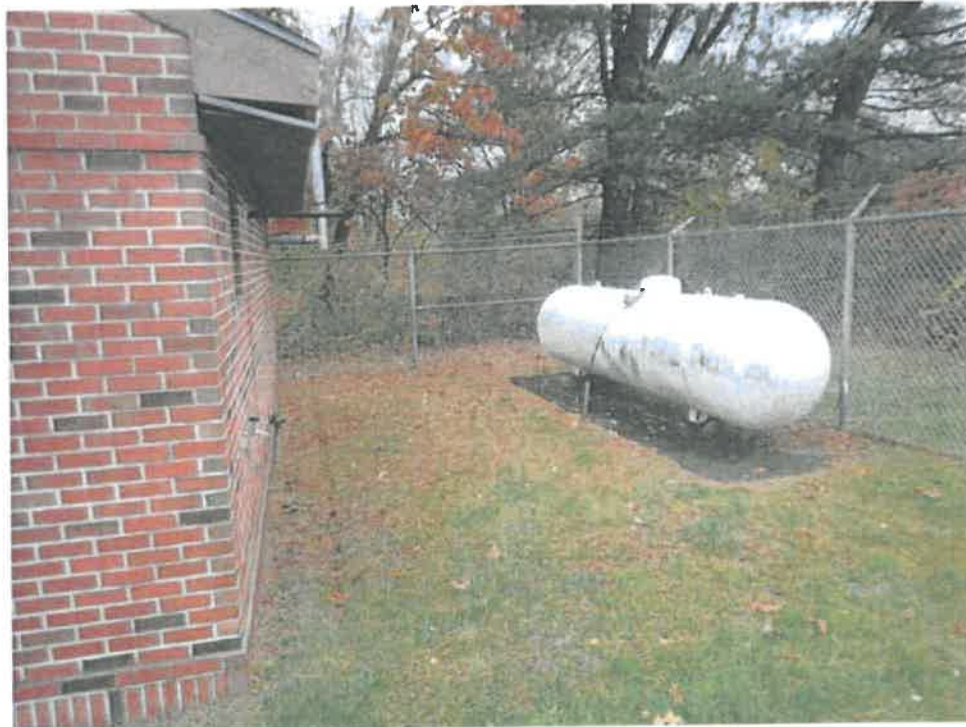
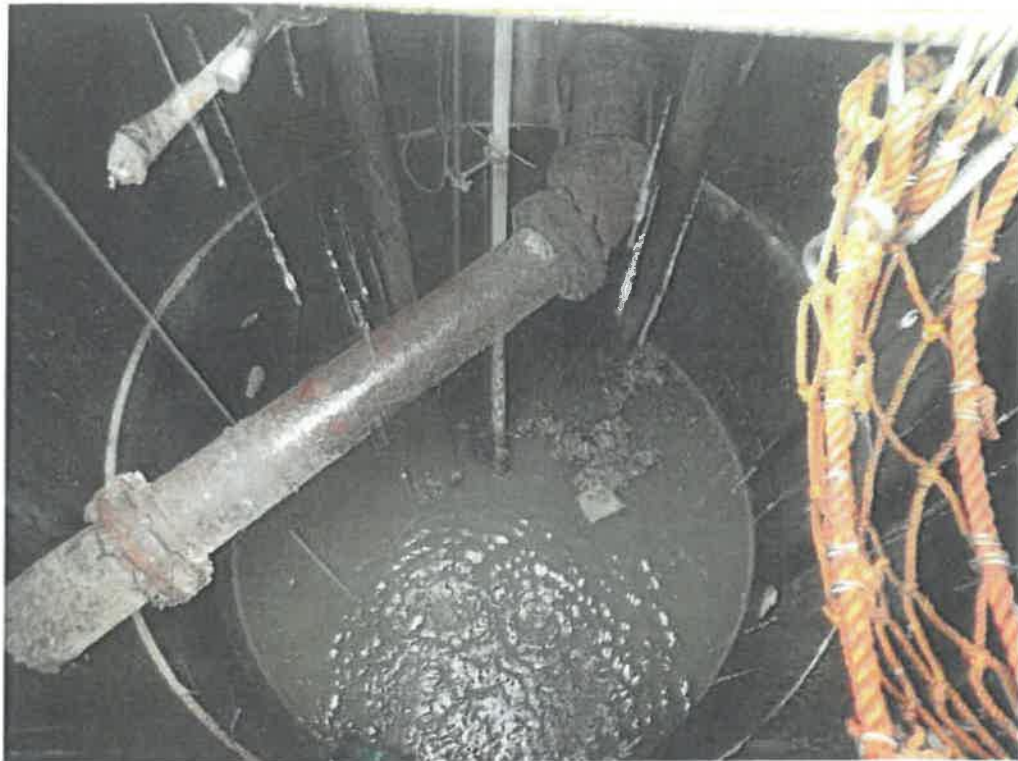
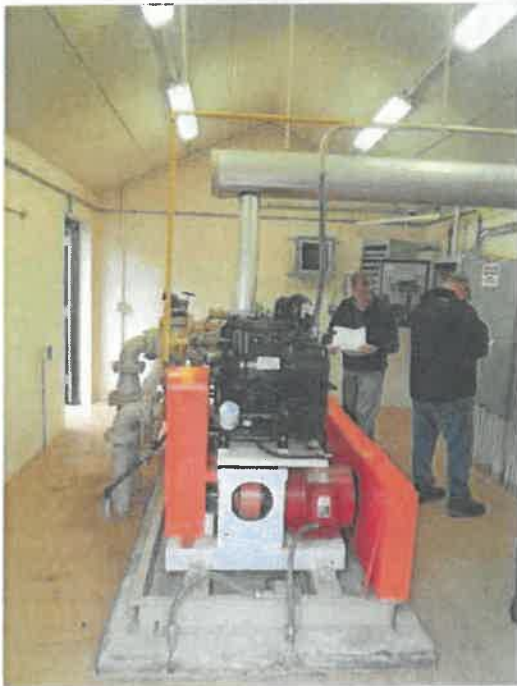
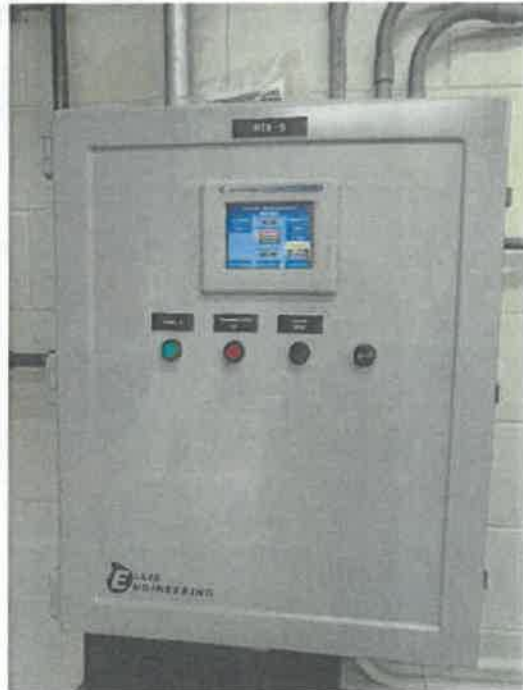
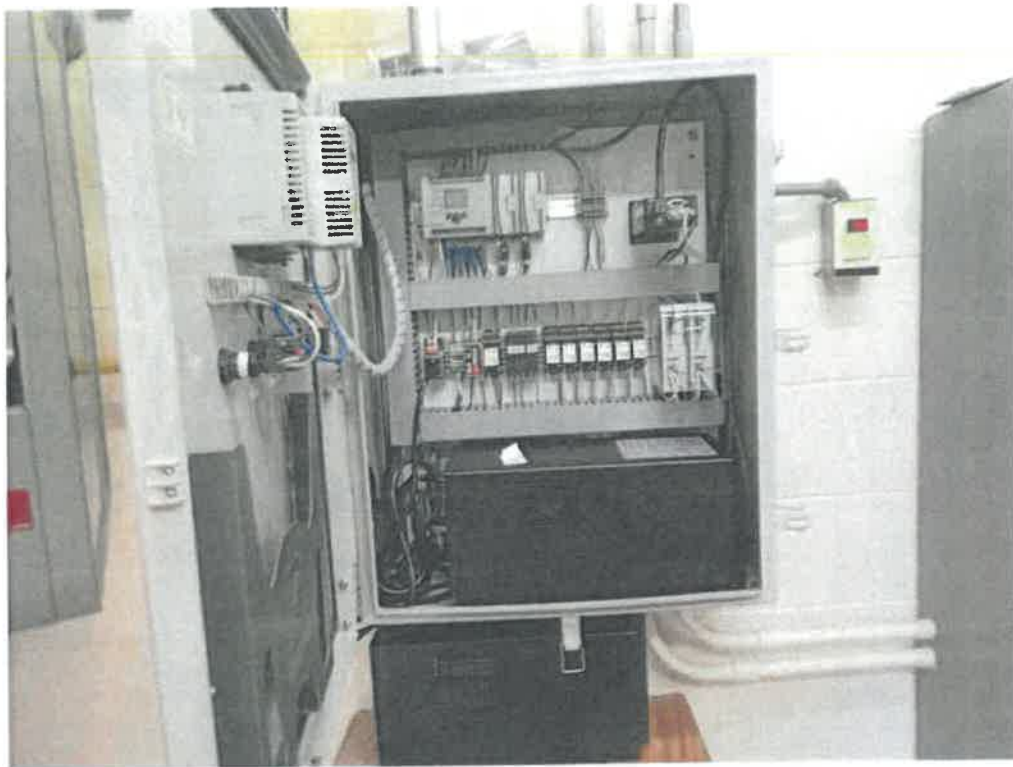
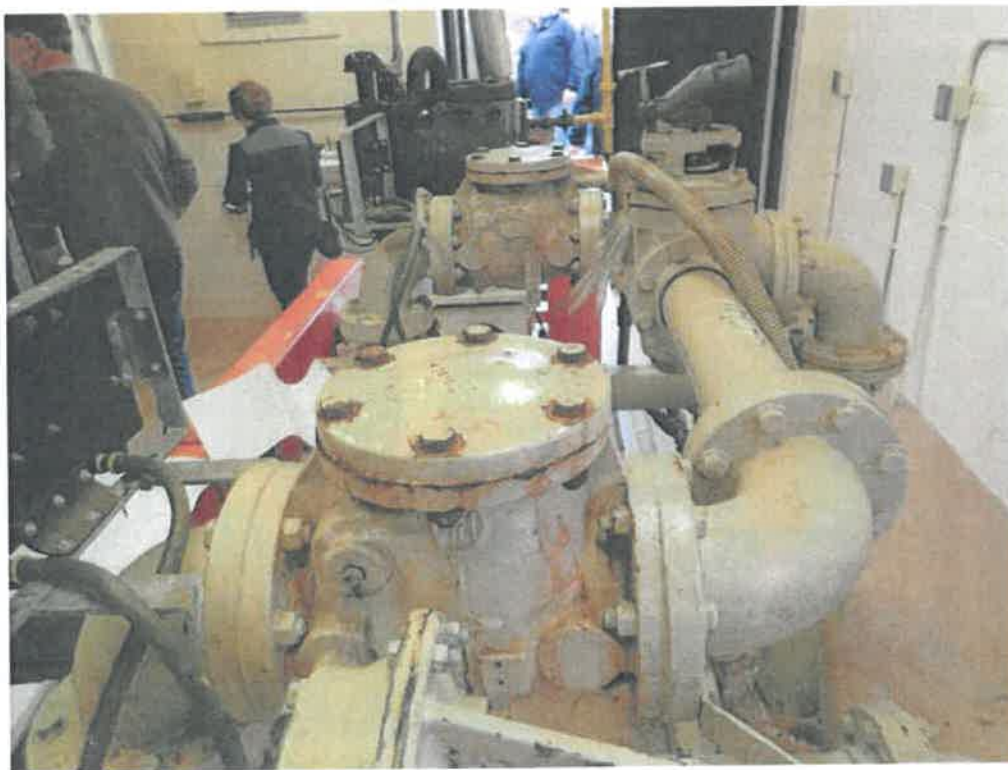
- Shingle roof is nearing end of 30-year life cycle. Has moss growing on it and should be replaced.
- Drip edge and fascia should be replaced. Eave soffit trim falling off. Fascia trim missing at ridge.
- Door surface and frame are beginning to rust. Should be replaced.
- Fencing around is in good condition.
- Ponding was observed around wet well hatch.
- Propane tank needs to be 25 feet from building and property line, per NFPA-58.

- Backup power is provided by an “Auto-Start” system and should be replaced. The Town requested all Auto-Start backup systems be converted to a stand-alone generator. This will require new electrical, plumbing, and concrete pad.

- Pumps, motors, piping, and valves are 28 years old but in fair condition. Should be replaced within 5 to 10 years.

- Wet well concrete walls are in fair condition but should be recoated to extended life expectancy.
- Piping and valves in wet well are in fair condition. Replacement should be considered in 5 to 10 years.

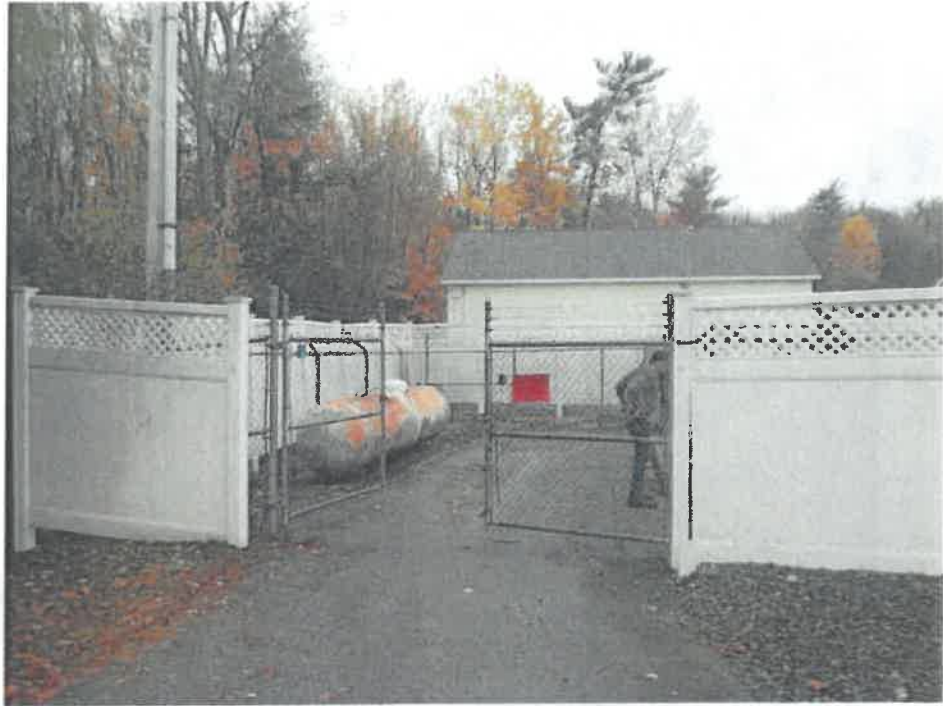
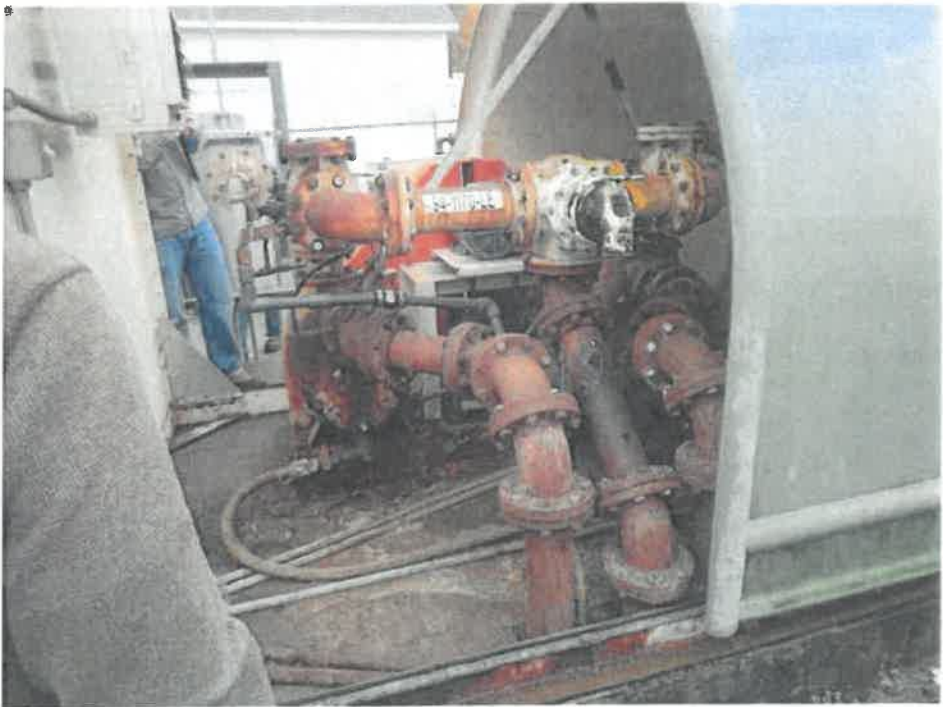
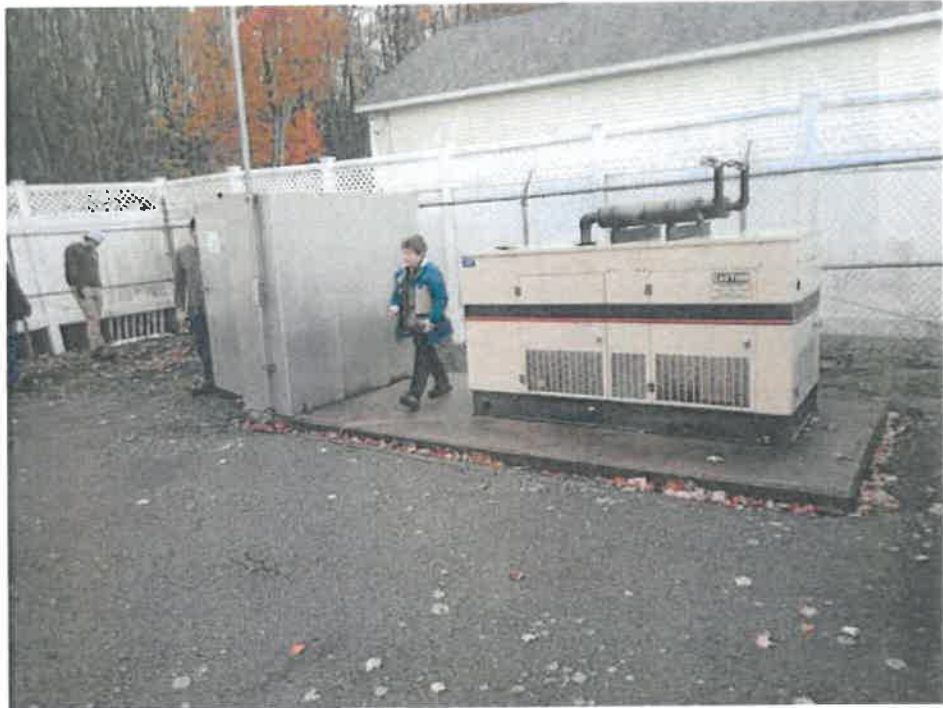
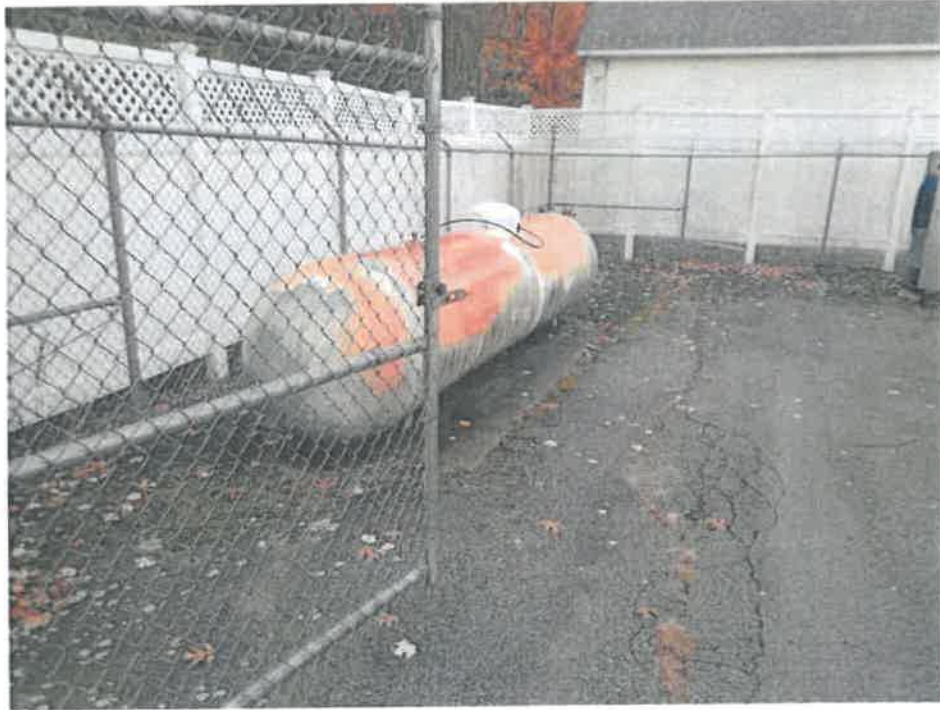
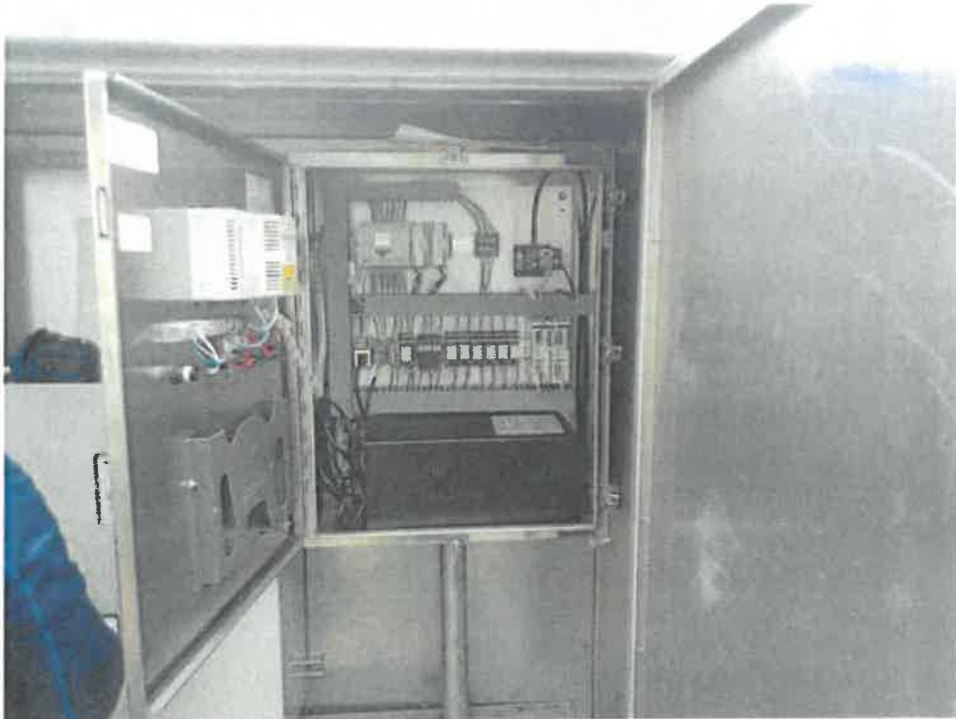
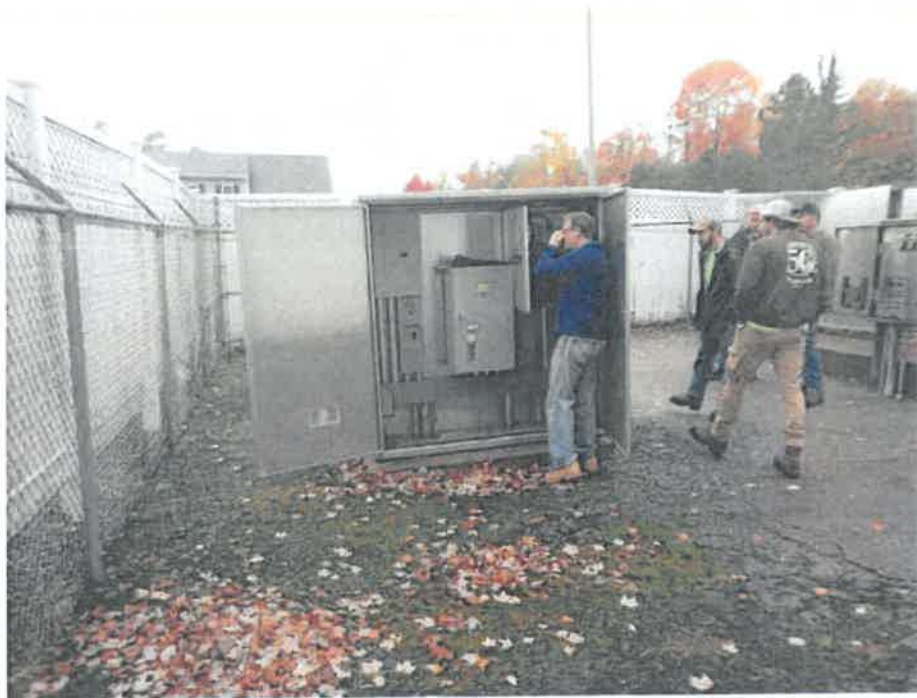
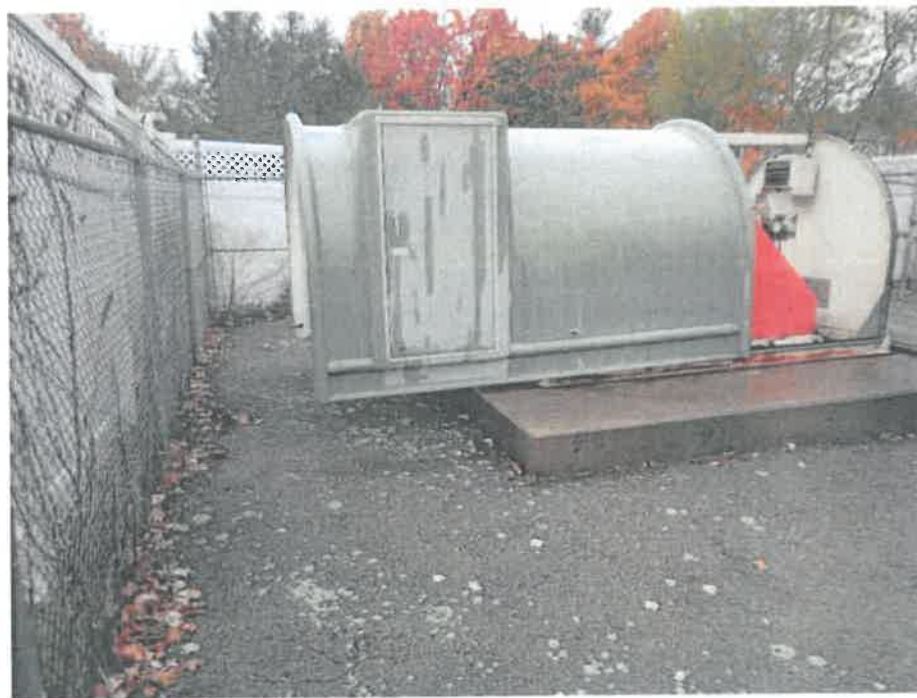
This station was commissioned in 1995. Two 175 gpm (5-hp) Gorman-Rupp pumps are contained in an above grade fiberglass arched enclosure on a concrete pad. The control panel is housed in an above grade service cabinet. A standby generator on a concrete pad is located outside. The system is a duplex pump system that draws wastewater from a concrete wet well located outside. A 1,000-gallon propane tank is located outside on a concrete pad. The following observations were noted during the evaluation of this pump station:

- Pumps are contained in an above grade fiberglass arched enclosure on a concrete pad. New building should be constructed to protect pumps from deterioration due to the elements.

- Fencing around the pump station is in good condition.
- Pavement is cracking, uneven, and settled in spots. Needs to be repaved.
- The propane tank's paint is deteriorated and needs to be repainted, and needs to be 25 feet from property line, per NFPA-58.

- Pumps, motors, piping, and valves are severely deteriorated and should be replaced.

- Severe corrosion of piping in wet well
- Float switches are deteriorated and should be replaced.

- The concrete pad the generator is on has settled and is uneven.
- Generator is 28 years old and has been exposed to the elements. Replacement is recommended.

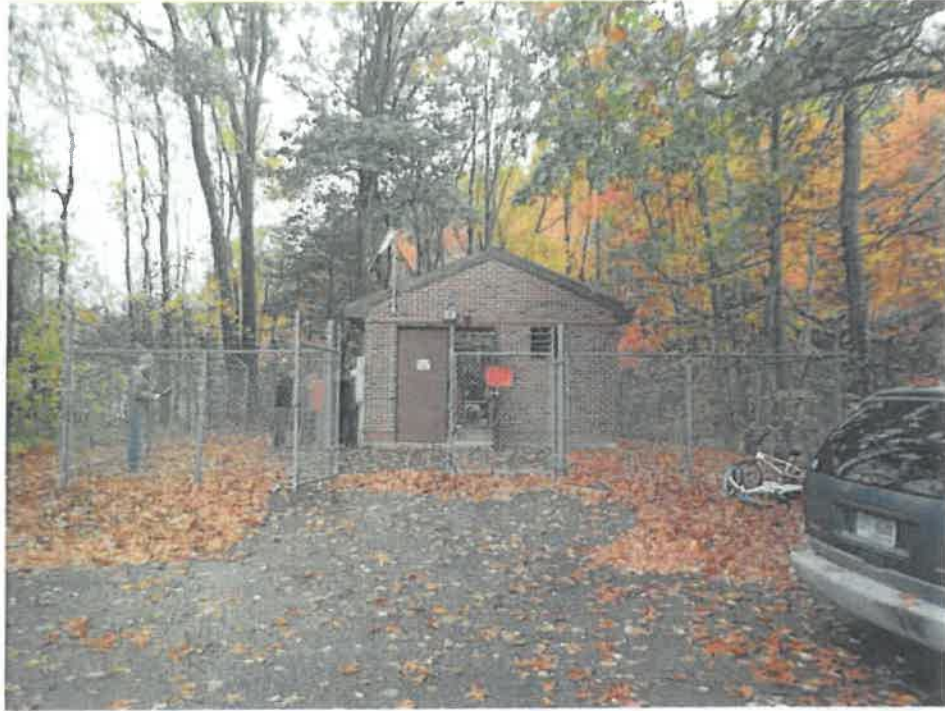
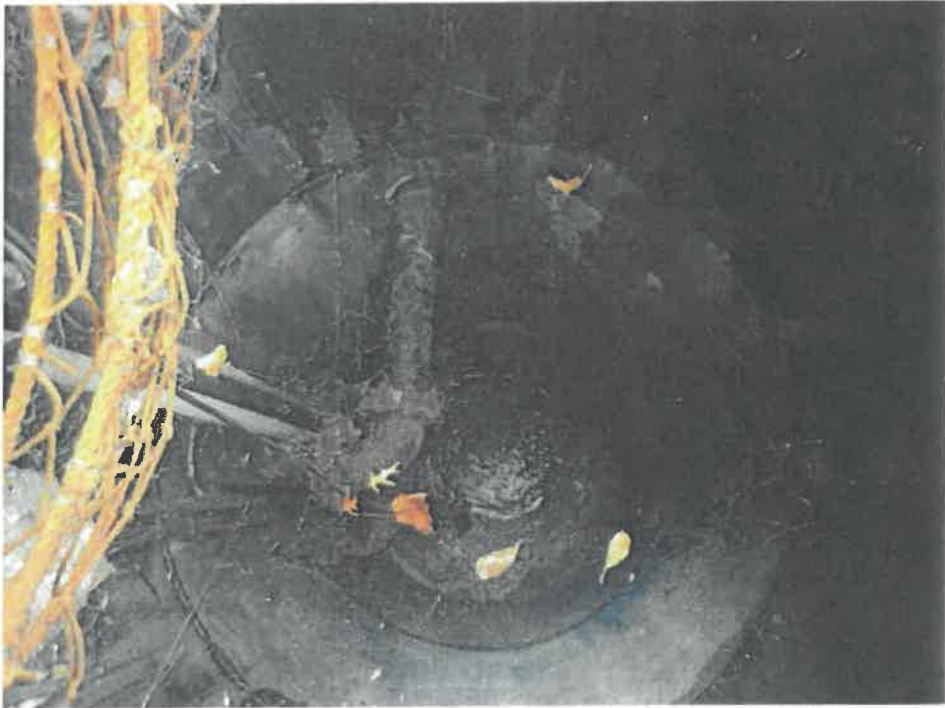
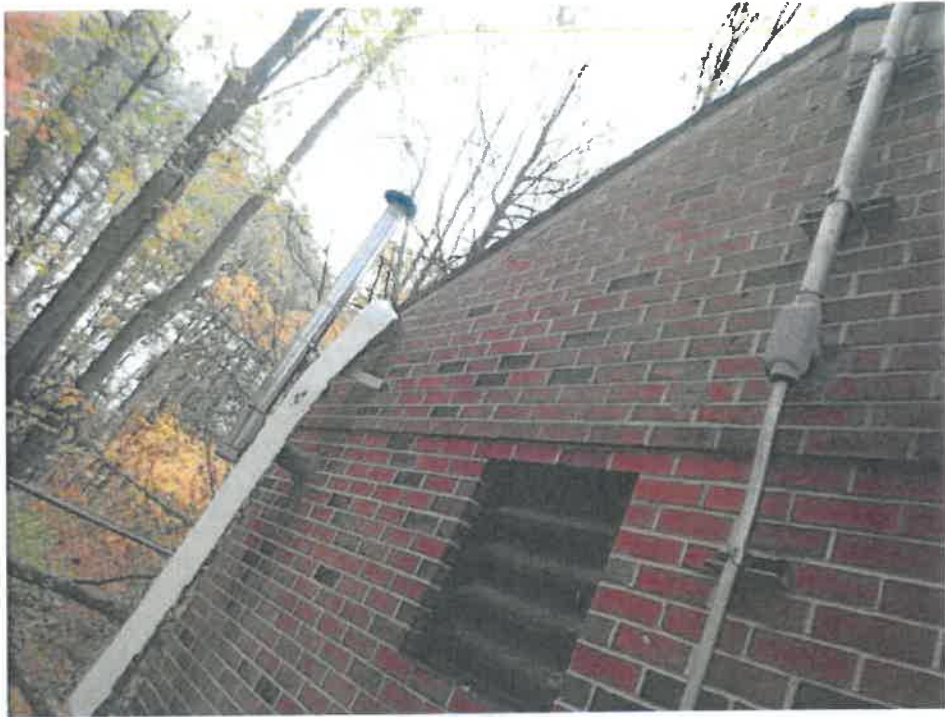
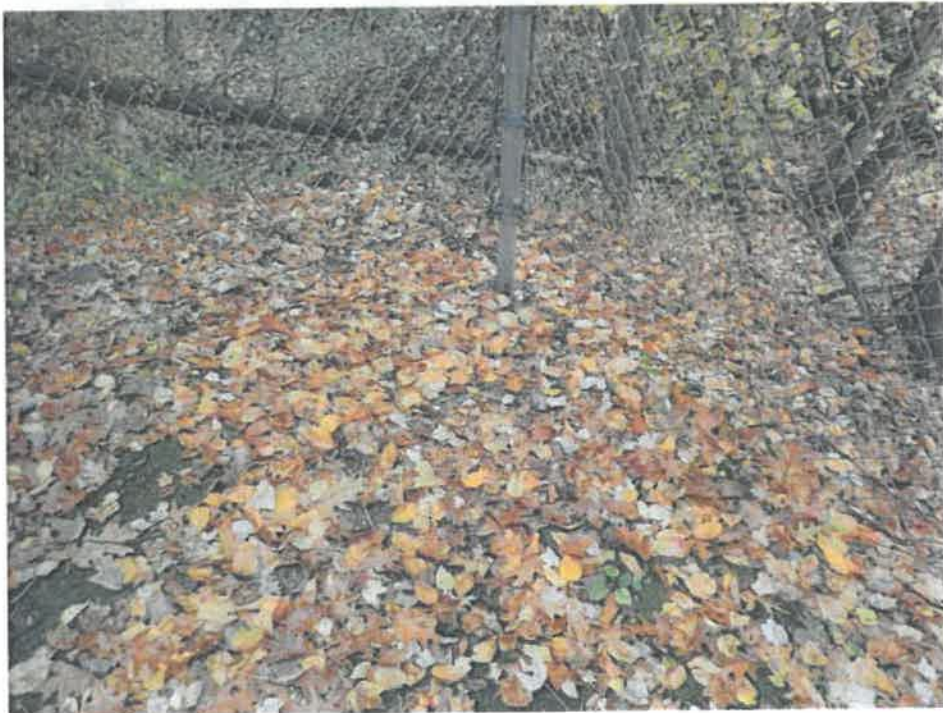
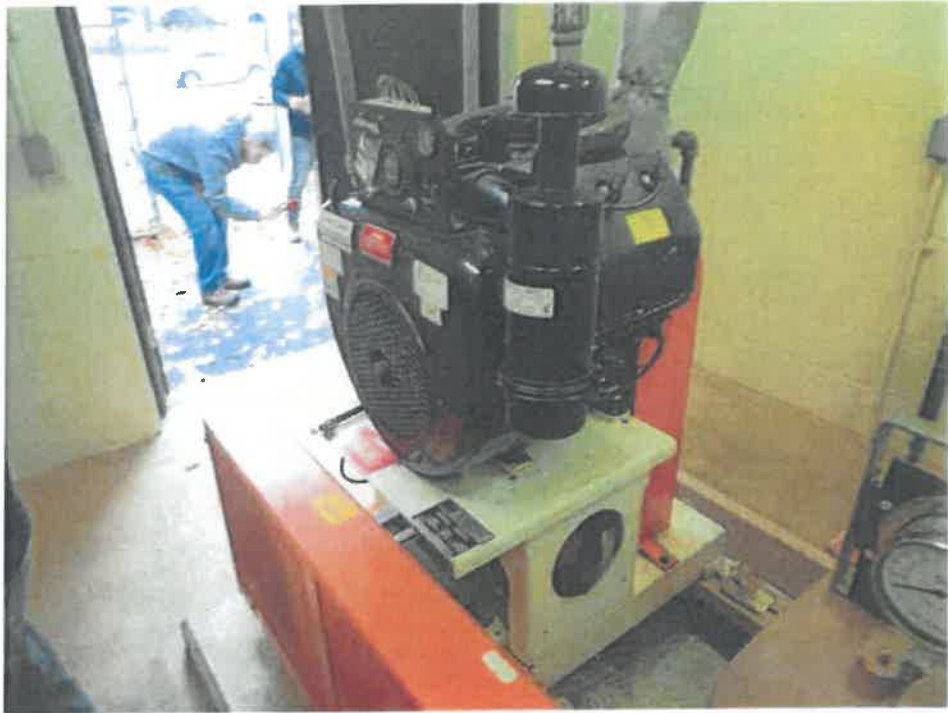
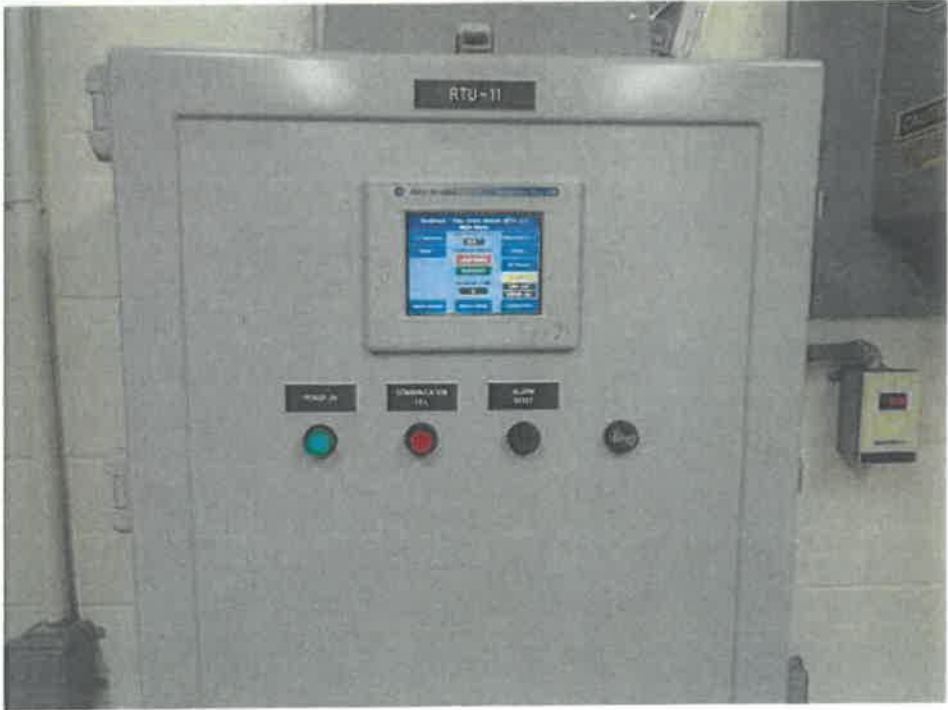
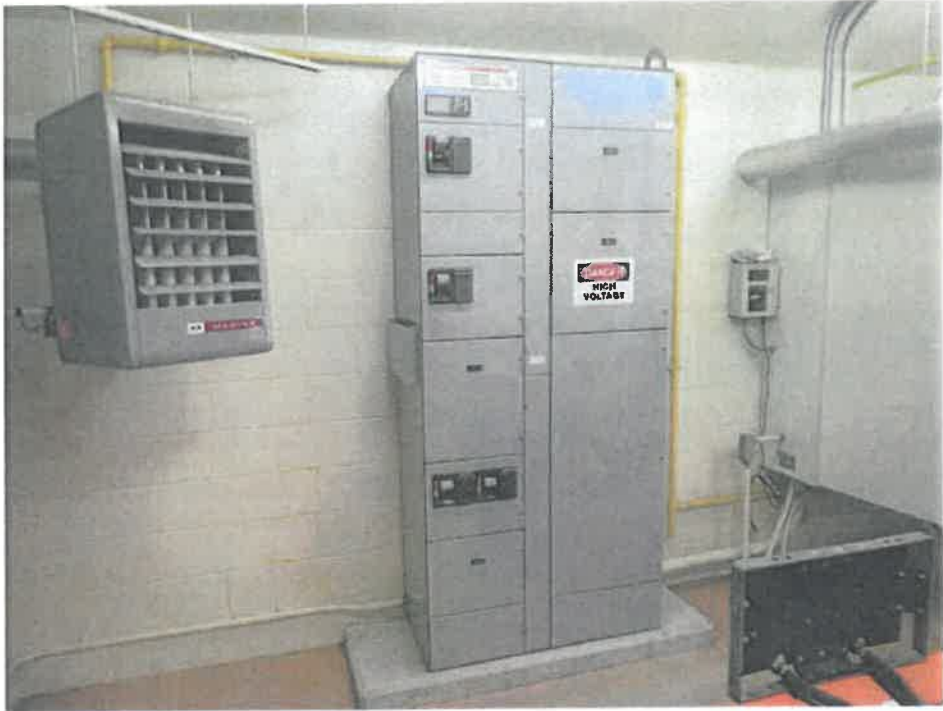
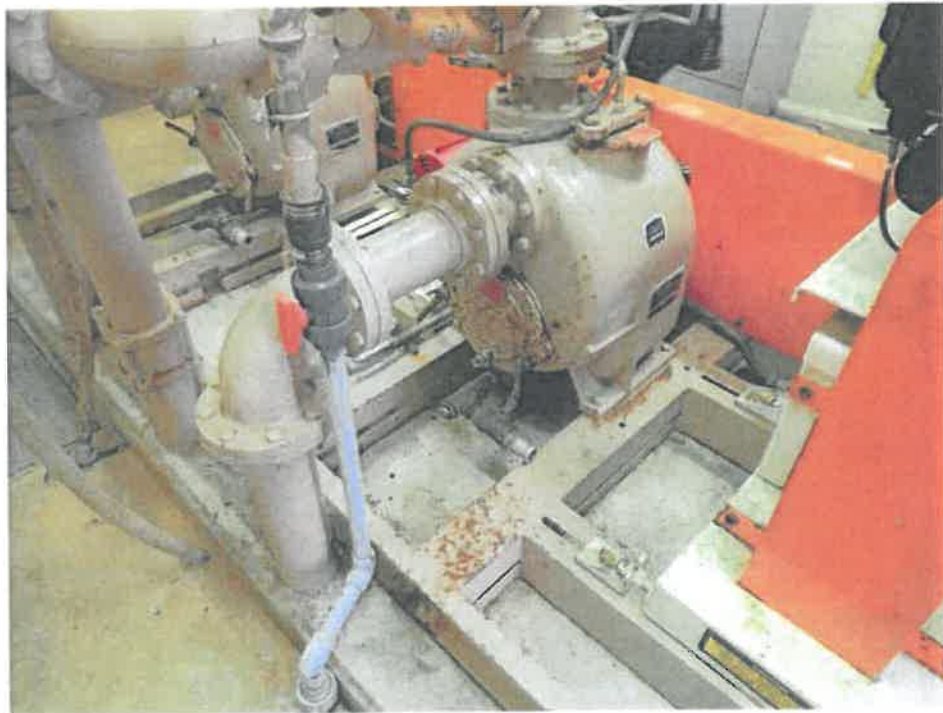
- Shingle roof is nearing end of 30-year life cycle. Has moss growing on it and should be replaced.
- Drip edge needs to be replaced.
- Doors and frame have begun to corrode and have rust. Should be replaced.

- Backup power is provided by an "Auto-Start" system and should be replaced. The Town requested all Auto-Start backup systems be converted to a stand-alone generator. This will require new electrical, plumbing, and concrete pad.

- Pumps, motors, piping, and valves are 28 years old but in fair condition. Should be replaced within 5 to 10 years.

- Explosion proof junction box is exposed to atmosphere and hanging by wires. Should be replaced immediately.
- Concrete walls of wet well show signs of deterioration and should be repaired.
- Float switches are deteriorated and should be replaced.
- Piping has corrosion and should be replaced in 5 to 10 years.

- Fencing around the station is in fair condition, however, back corner of fence has a gap at the bottom and should be repaired.

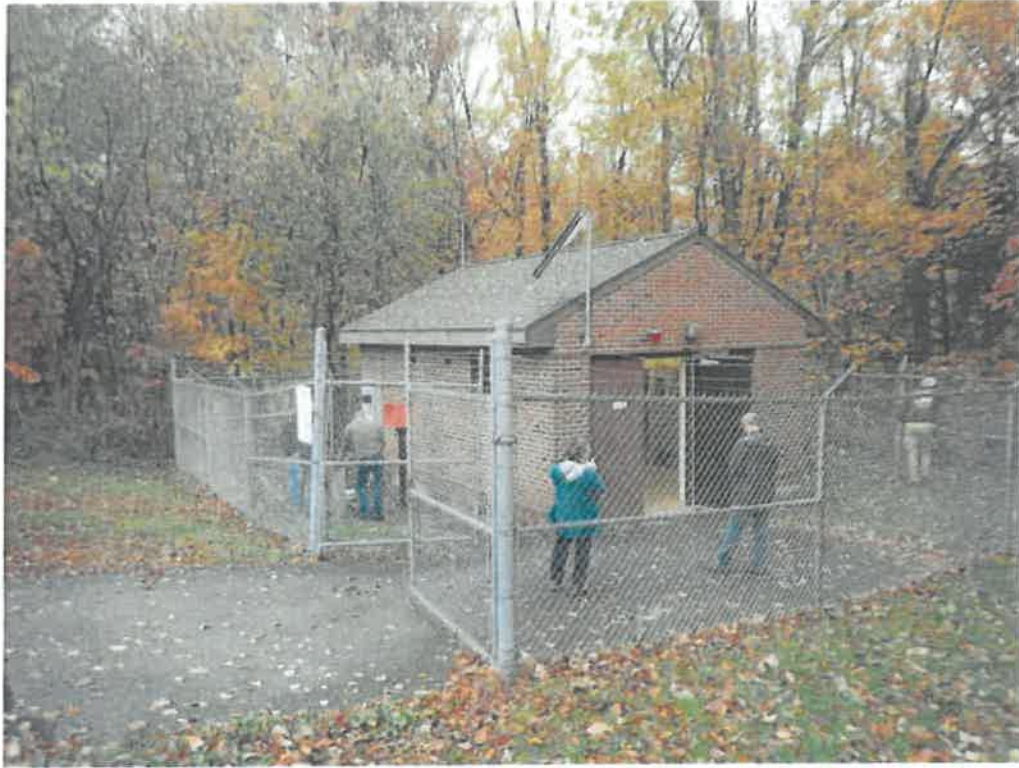
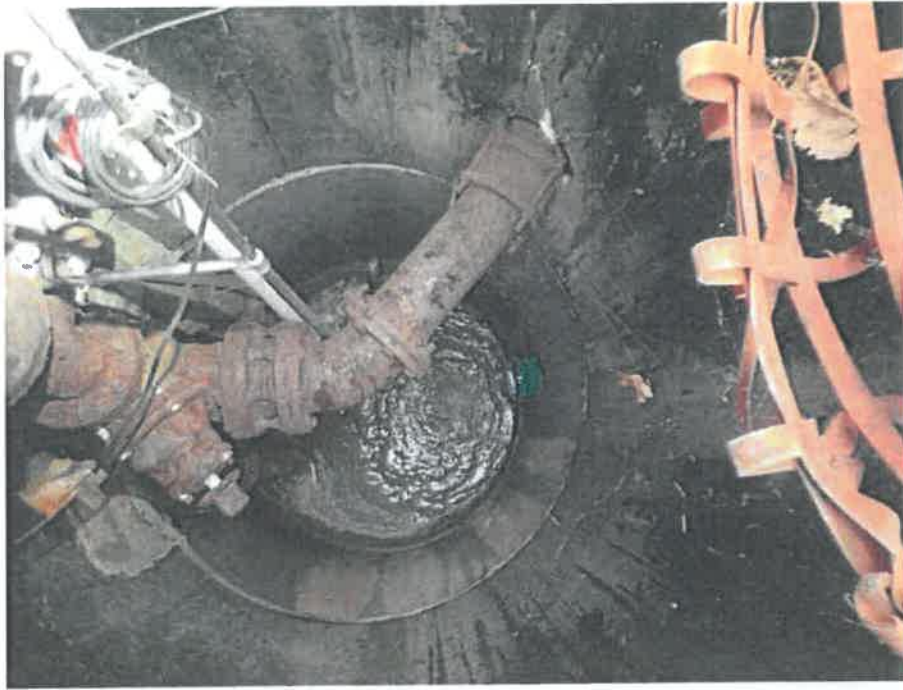
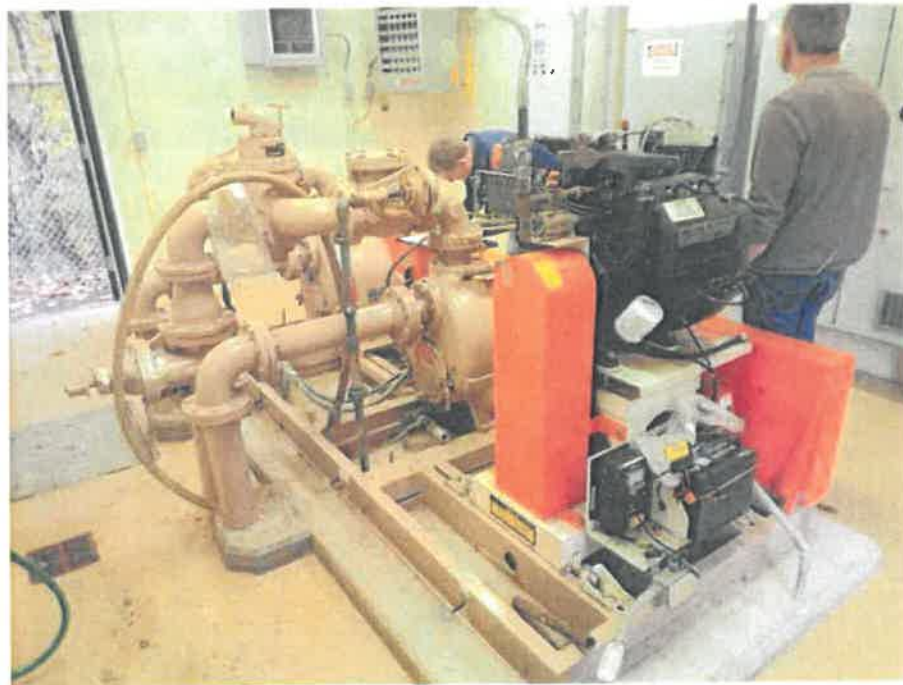
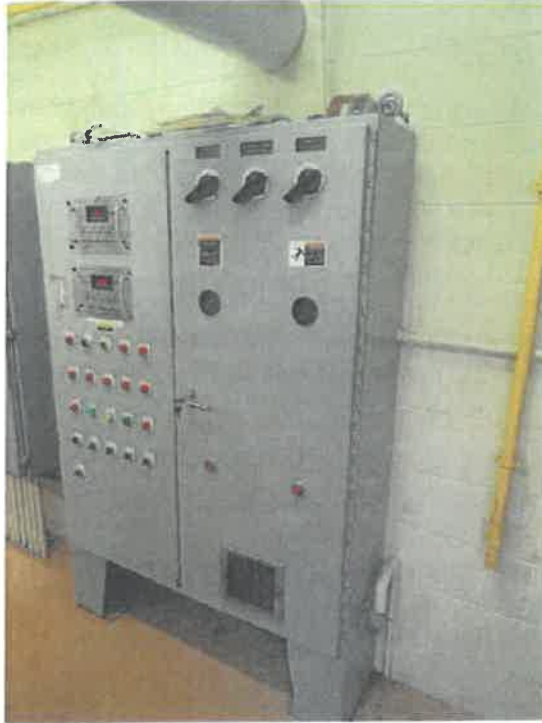
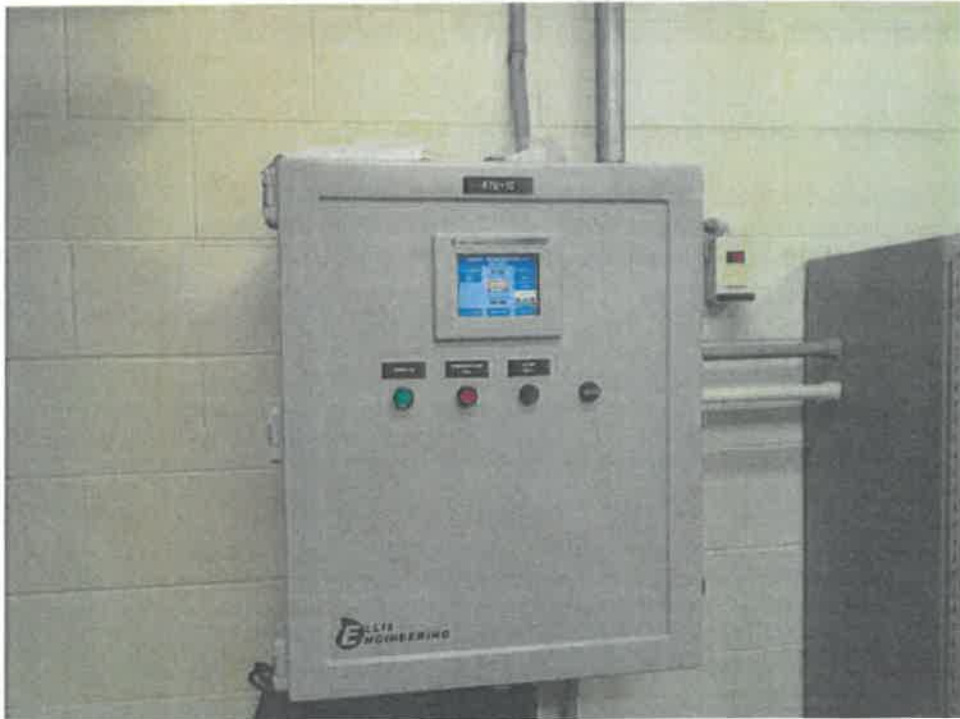
- Auto-Start system controls should be replaced with a new control panel.

- Pumps, motors, piping, and valves are 28 years old but in fair condition. Should be replaced within 5 to 10 years.
