WESTON & SAMPSON ENGINEERS, INC.
100 International Dr, Suite 152
Portsmouth, NH 03801
tel: 603.431.3937

FINAL REPORT

TOWN OF
Seabrook
New Hampshire

Weston & Sampson is pleased to submit this report on evaluations conducted on the Town of Seabrook wastewater pump stations. The draft report presents our findings for work completed under this project, including collected pump station information, general observations and deficiencies, recommendations for improvements, and a prioritized master plan.

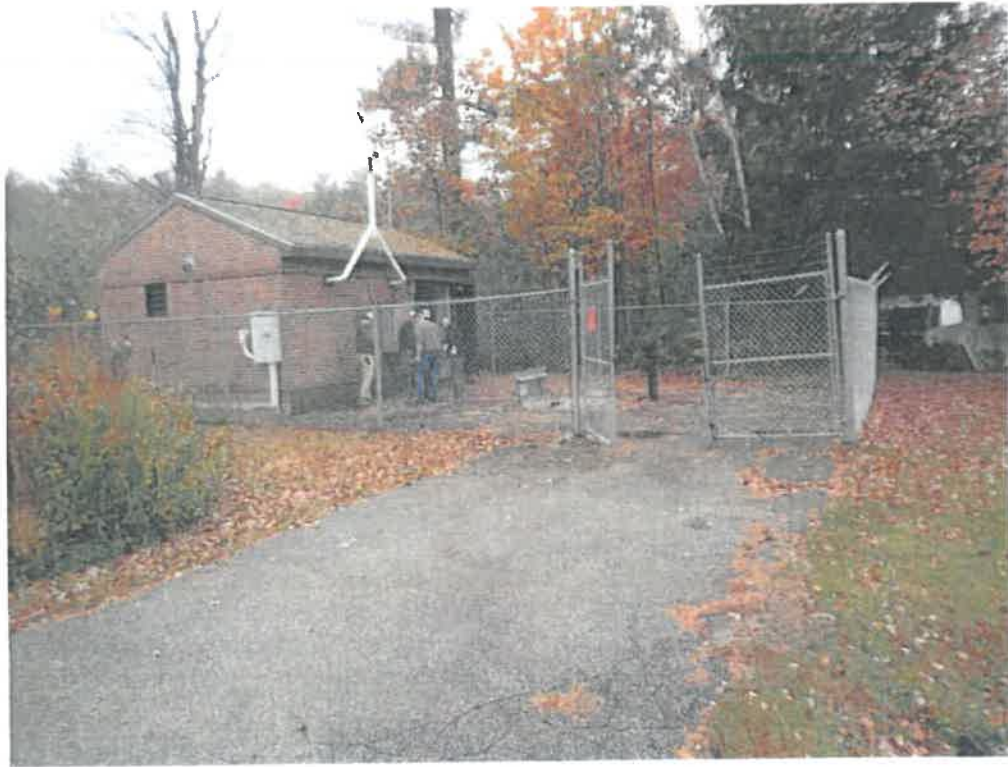
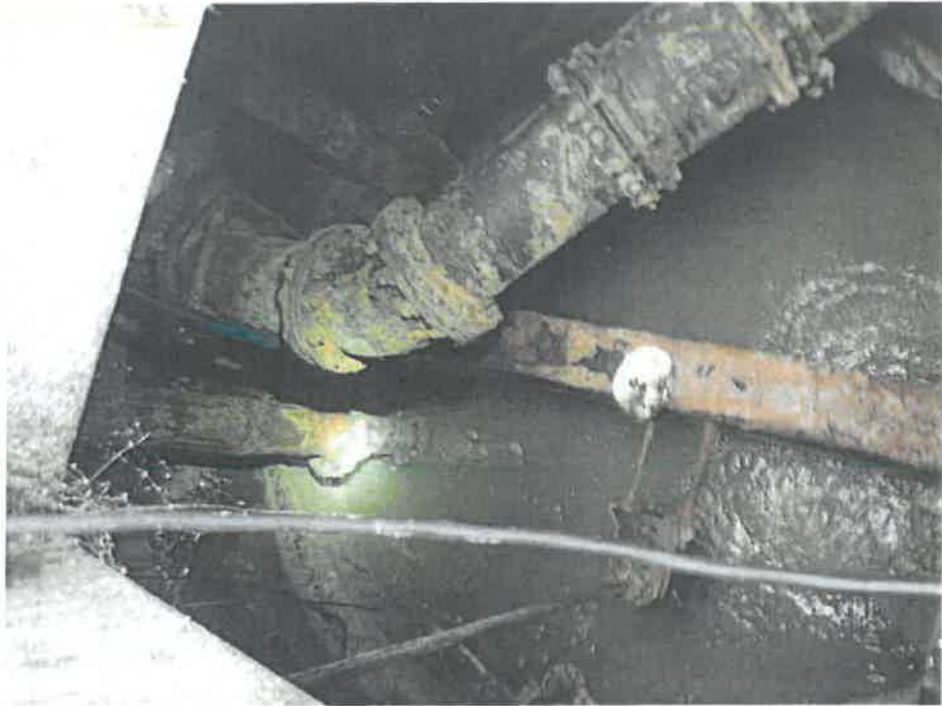
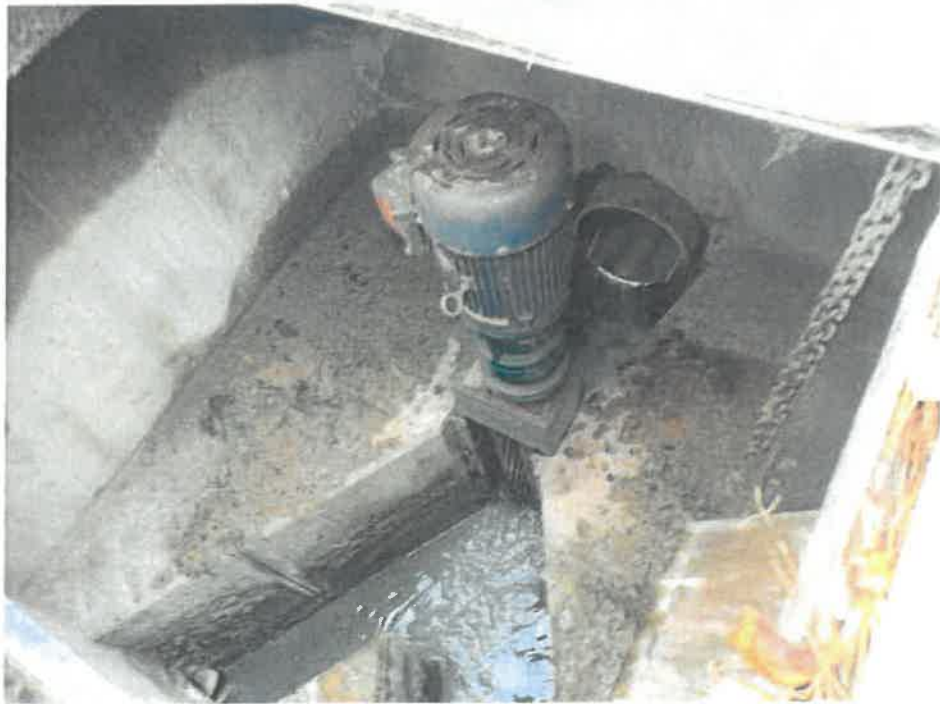
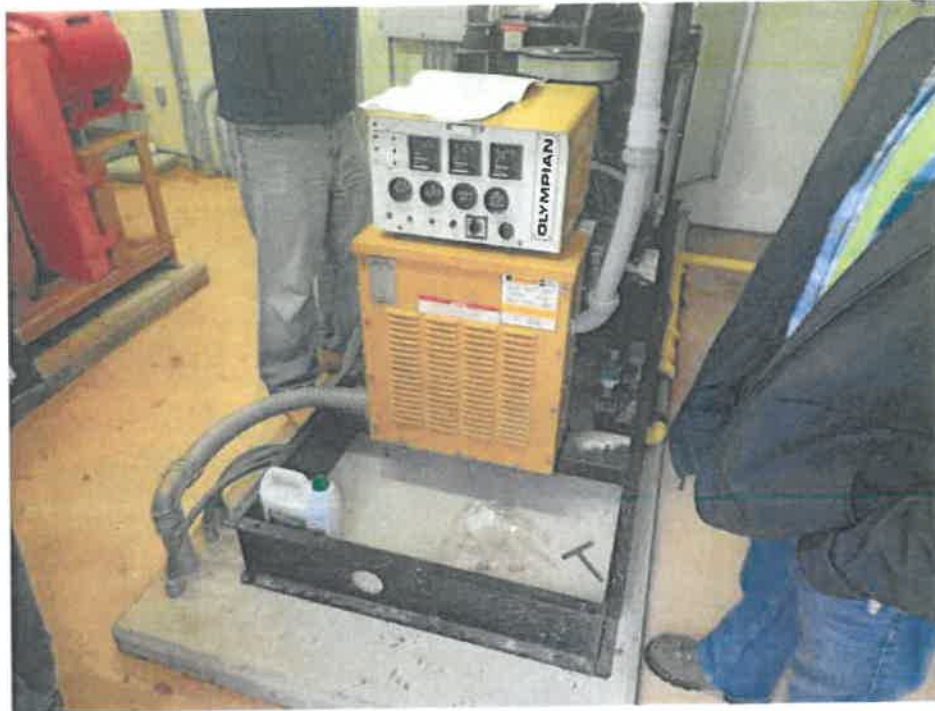
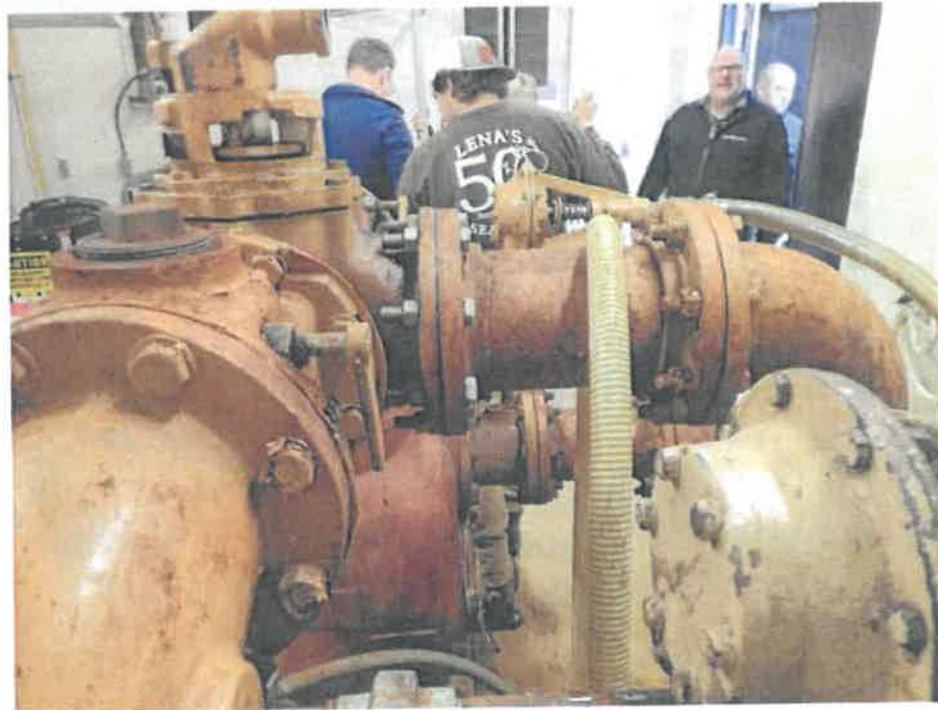
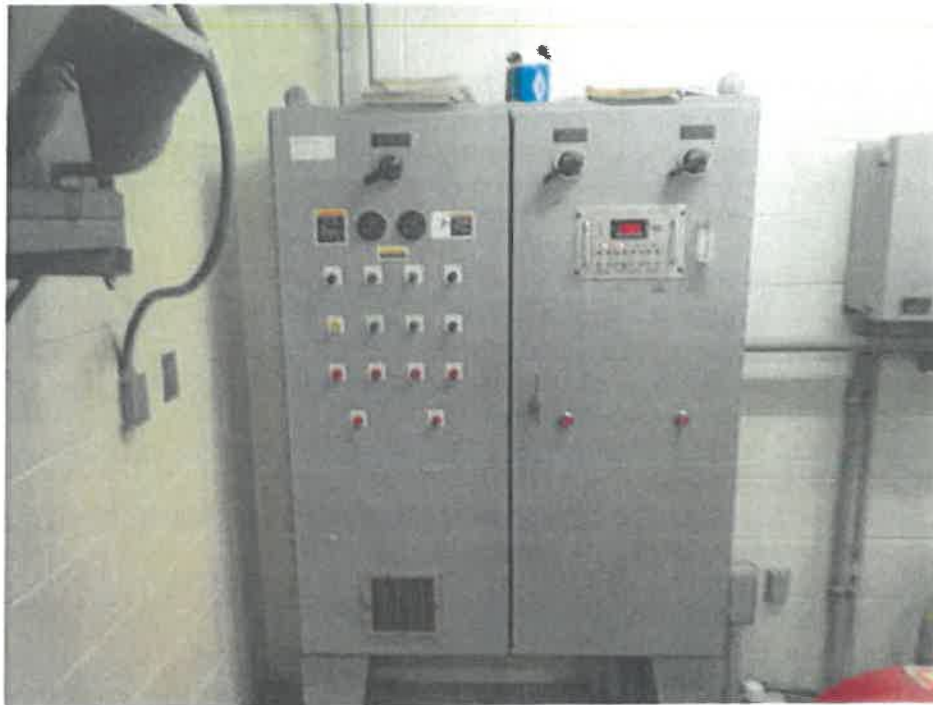
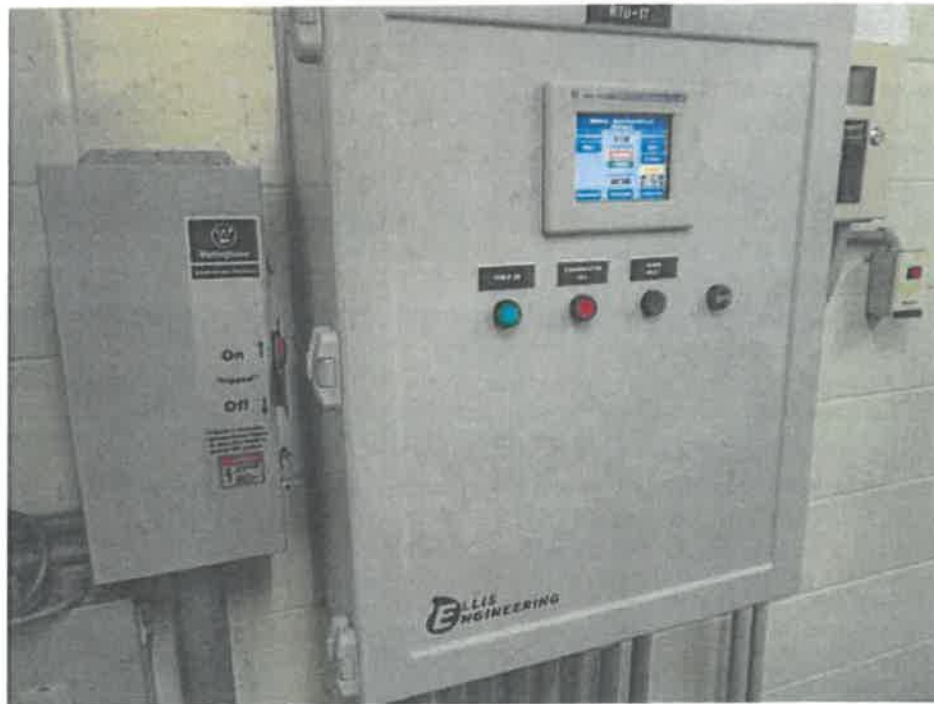
RTU-17: Rocks Road Pump Station

This station was commissioned in 1995. Two 800 gpm (25-hp) pumps are contained in a concrete building. The controls and electrical systems, as well as a standby generator on a concrete pad are located within the concrete building. The system is a duplex pump system that draws wastewater from a concrete wet well located outside of the building. The following observations were noted during the evaluation of this pump station:

- Shingle roof is nearing end of 30-year life cycle. Has moss growing on it and should be replaced.
- Drip edge needs to be replaced.
- Door surface paint is faded and beginning to rust. Should be replaced.
- Fencing around the station is in fair condition.

- Floor not pitched correctly and has standing water from a leaking back flow.
- Ceiling has some cracking and paint peeling.

- Pumps, motors, piping, and valves are 28 years old and beginning to corrode. Should be replaced.

- Flow meter needs to be replaced.
- Float switches are deteriorated and should be replaced.
- Muffin Monster sewage grinder cutters are worn and require replacement.
- Seabrook staff noted force main was replaced, and suction lines are good.
- No fall protection.

- Generator is 28 years old. Routine maintenance should be performed, and replacement should be considered within 5 to 10 years.

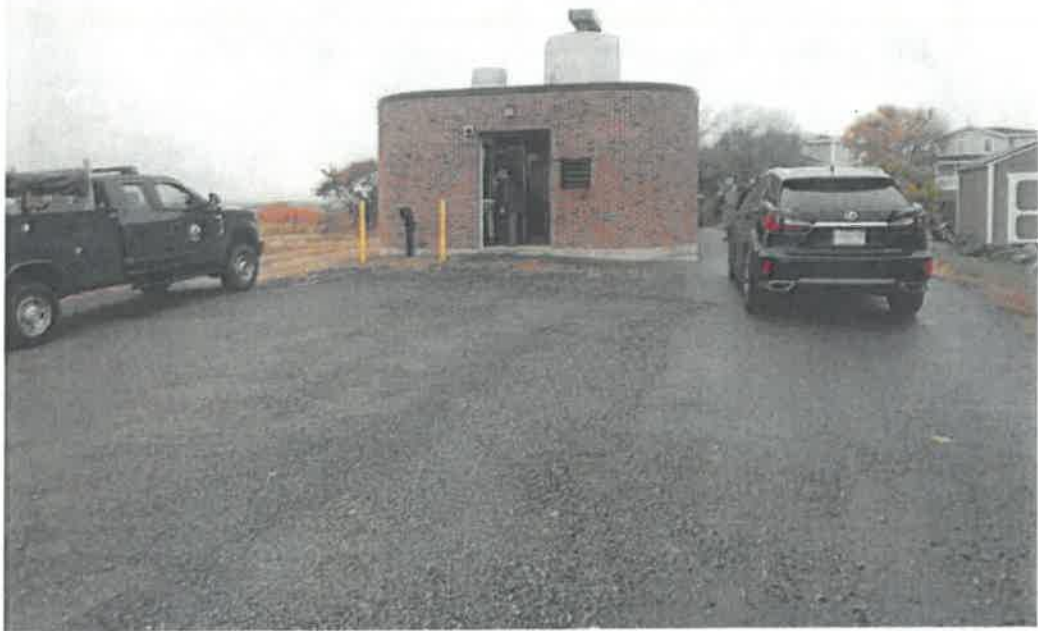
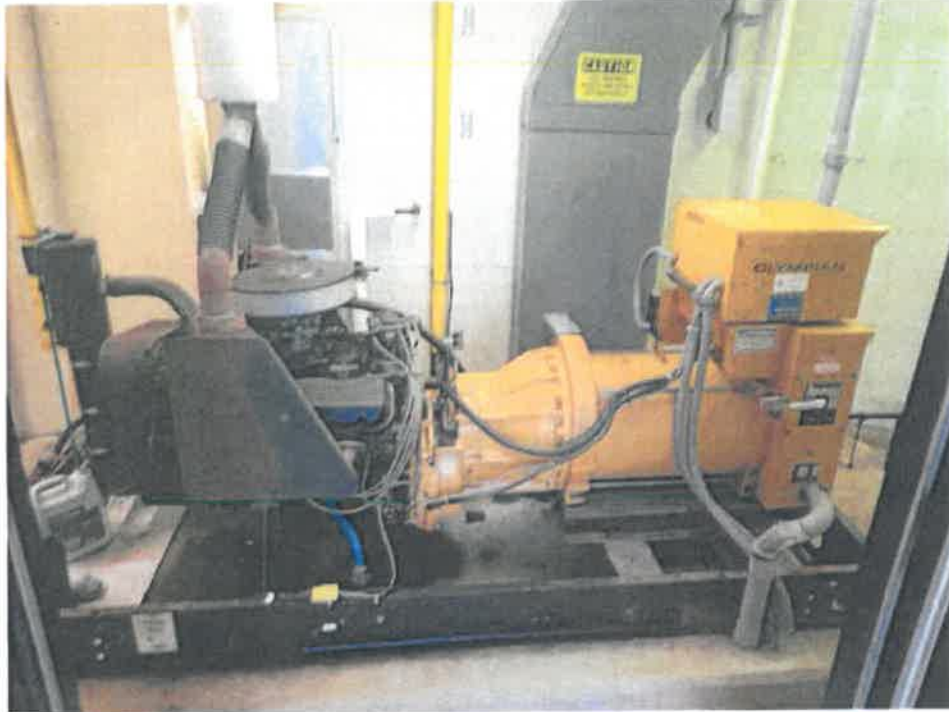
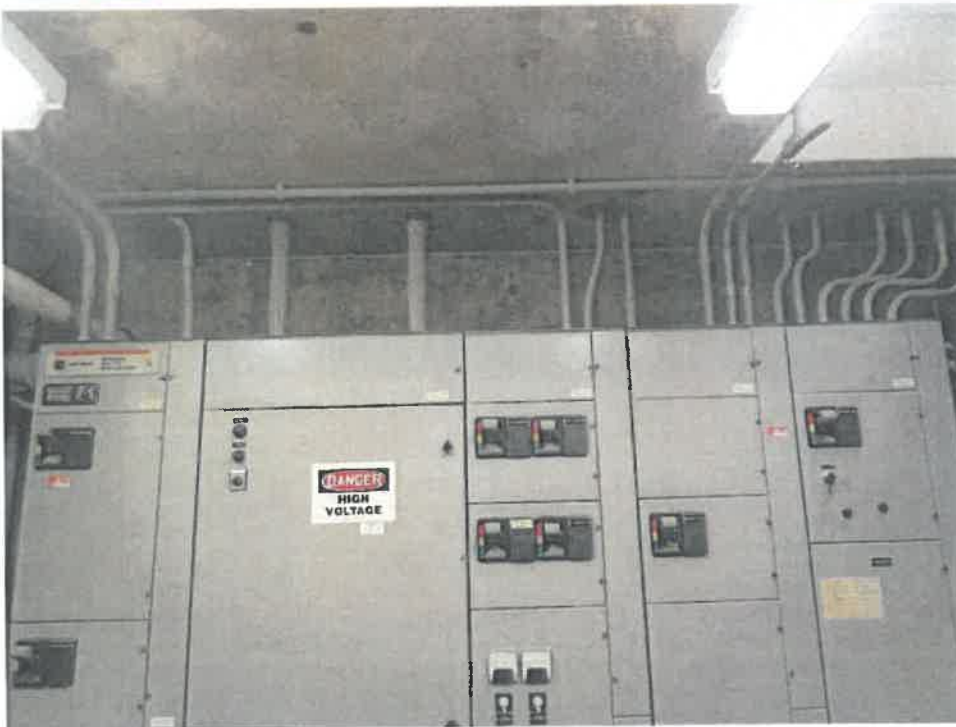
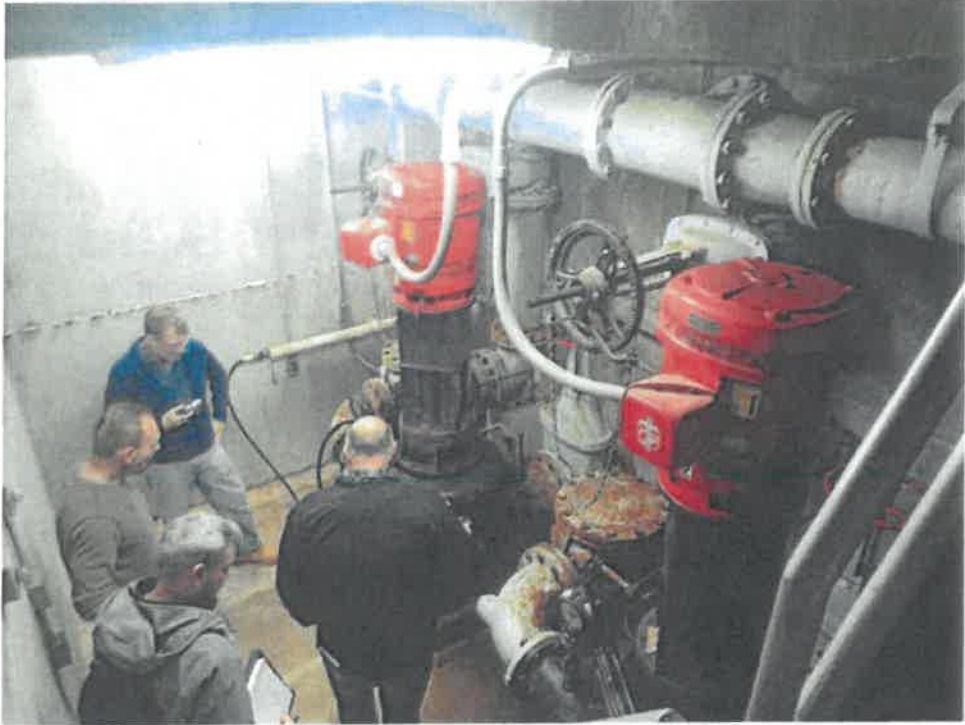
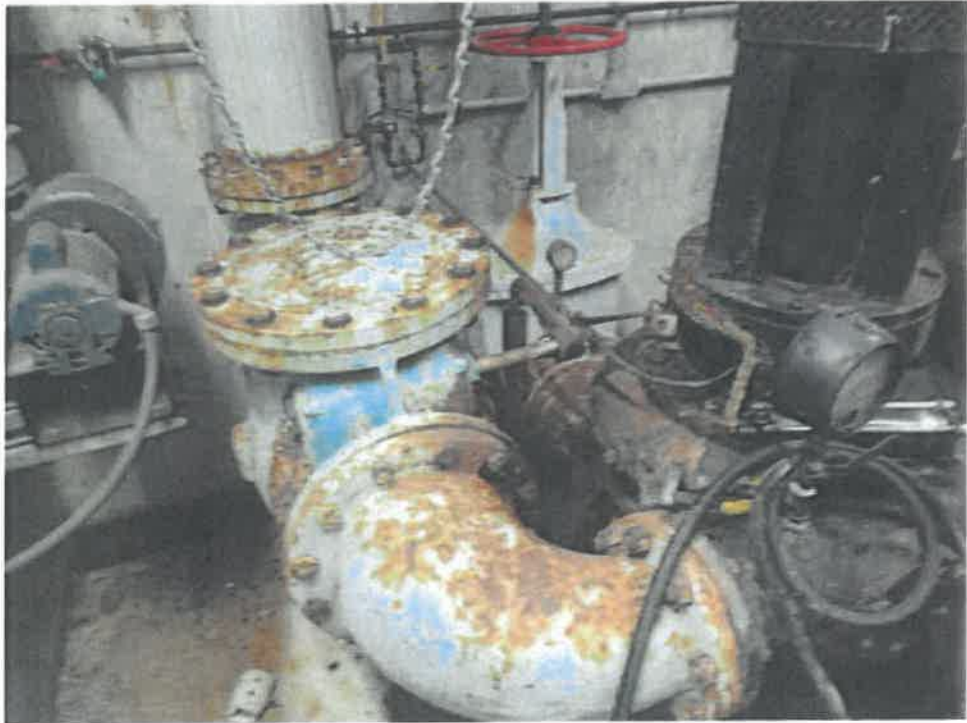
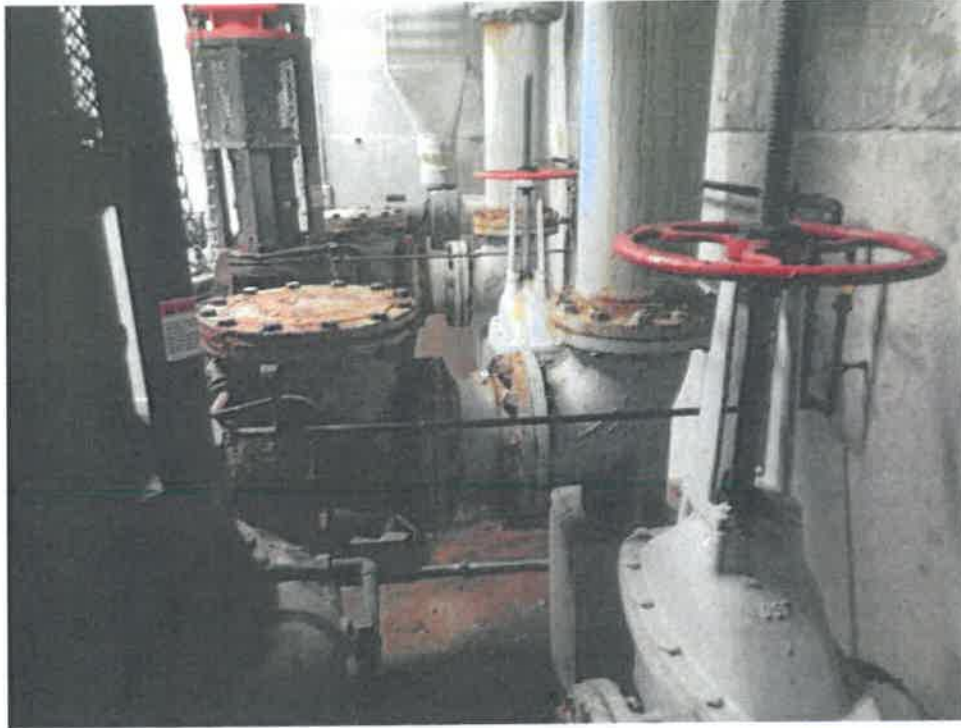
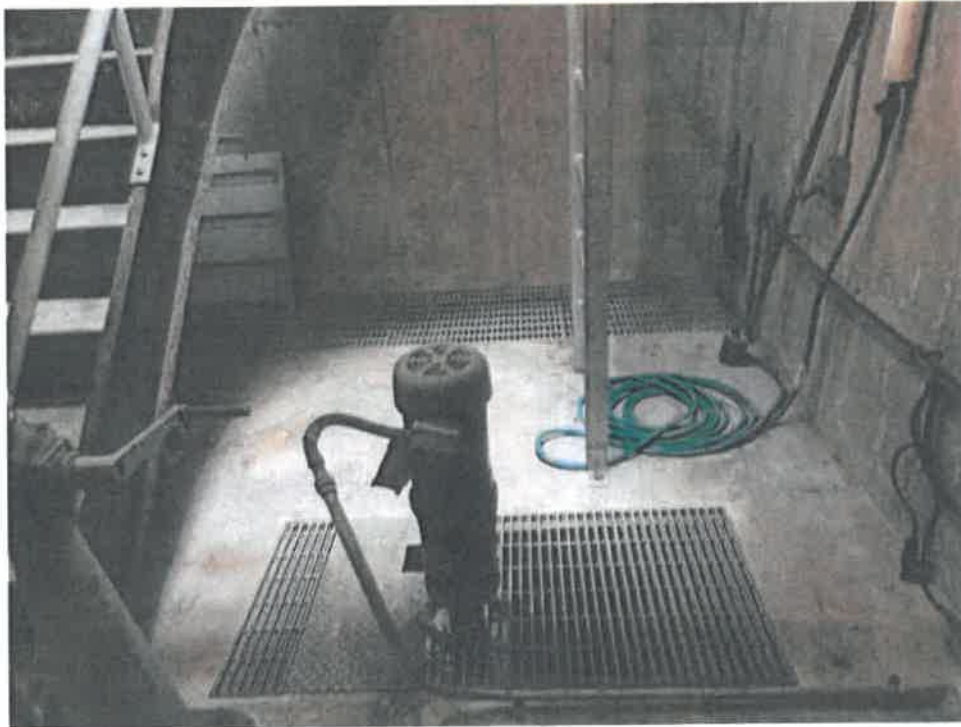
RTU-18: Route 286 Pump Station

This station was commissioned in 1995. The flooded suction station contains two 1,500 gpm (25-hp) Fairbanks-Morse pumps located in a concrete structure below grade. A standby generator is located at ground level on a concrete pad in a separate room in the building. The controls and electrical systems are housed in an adjacent concrete building. The following observations were noted during the evaluation of this pump station:

- The ballasted membrane roof that is in marginal condition and should be replaced.
- Some blades are missing from the louvers.
- Control joint sealant is deteriorated and should be replaced.
- No splash block at roof drain outlet

- Sample pump control panel and pump control panel should be upgraded.
- Floor could use new coating.
- Paint is chipping and some corrosion is visible on the wall surface.
- Door and door components have significant visible corrosion and should be replaced.
- Motor at louver is corroded.
- Potable and non-potable water needs to be separated.
- Electric unit heater needs replacement.
- Emergency shower and service sink should have tempered water.

- Roof has leaks, moss growing on surface, and insulation deterioration and should be replaced.
- Exhaust fan is rusted and should be replaced.
- Control joint sealant is deteriorated and should be replaced.
- Door and door components have significant visible corrosion and should be replaced.

- Pumps, motors, piping, and valves are severely deteriorated and should be replaced.
- Floors could use cleaning and new coating.
- Wall paint is chipping, and corrosion is visible on wall surface. Needs new paint.
- Doors and door components have severe corrosion and should be replaced.
- Stairs and stair components have visible rust and should be replaced.
- Muffin Monster sewage grinder cutters are worn and require replacement.
- Dehumidifier needs replacement.
- Exhaust fan in lower level of dry well needs intake opening protection.

- Generator is 28 years old. Routine maintenance should be performed, and replacement considered in 5 to 10 years.

- The pavement is in good condition.
- There is no fencing around the building.
